**Pine Creek Village Association
Colorado Springs, CO**

Report #: 10332-0
Beginning: January 1, 2023
Expires: December 31, 2023

**RESERVE STUDY
Update "With-Site-Visit"**

August 30, 2022

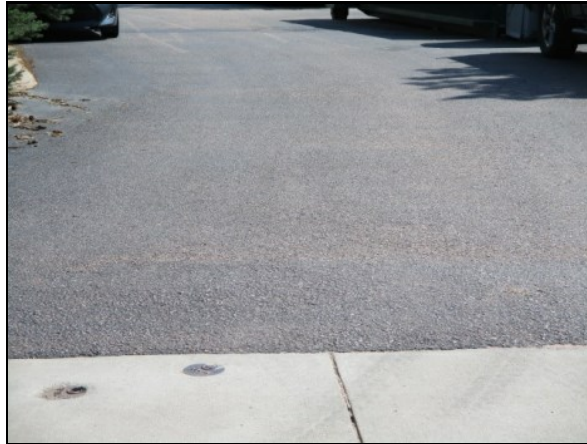
Comp #: 21190 Asphalt - Seal/Repair

Useful Life:
4 years

Remaining Life:
0 years

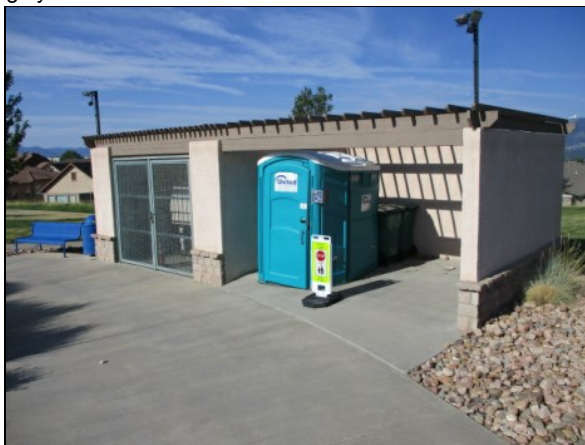
Comments: Pergola structures determined to be in fair condition typically exhibit more wear and tear possibly including some warped split and/or deteriorated components. Framework/structure should still be sturdy but may have sections showing minor leaning or damage. As routine maintenance inspect regularly and repair individual pieces or sections as needed from general Operating funds. Clean and paint/stain along with other larger projects or as general maintenance to preserve the appearance of the pergola and extend its useful life. If present vegetation should be well-maintained and not allowed to become overgrown which can eventually compromise the structure. Assuming ordinary care and maintenance plan for major repairs or possibly complete replacement (if warranted) at roughly the interval indicated below.

Useful Life:
30 yearsRemaining Life:
18 years
