Regarding: Reserve Study Final Version

Level 2, Premium Reserve Analysis

La Bellezza at Pine Creek Village

3775 Palazzo Grove
Colorado Springs, CO. 80303

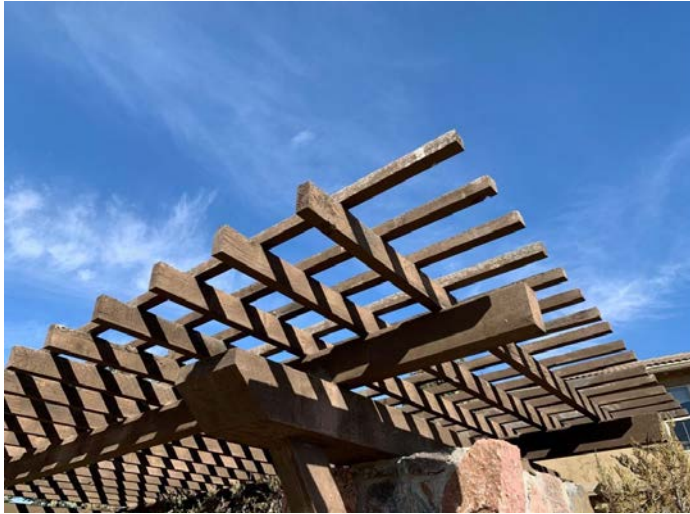
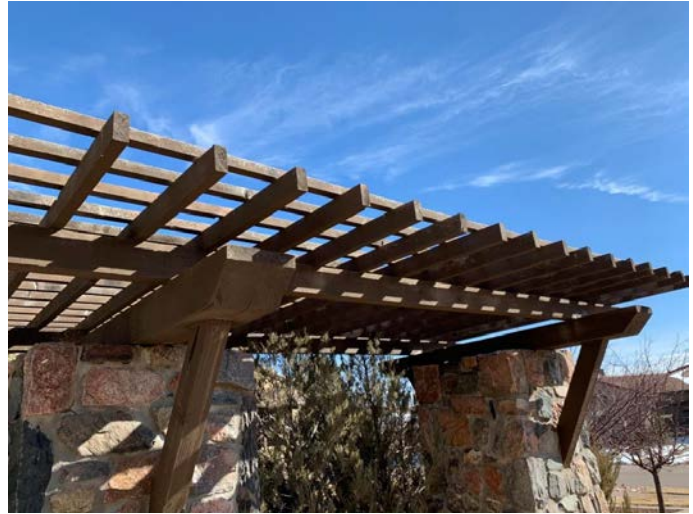
Comp #: 202 Wood Trellis - Repaint

- Based on observed conditions, we recommend staining in 2020.
- Due to the small area and relatively low cost, we suggest repaint these surfaces on an as needed basis with operating funds. Therefore, separate Reserve funding is not necessary at this time.

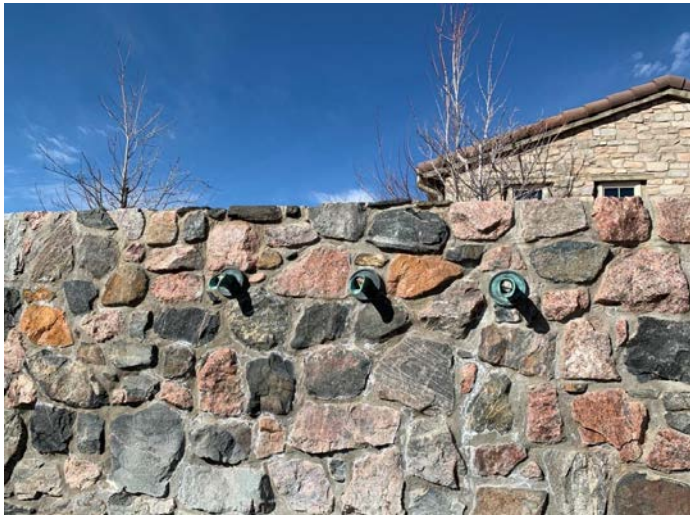
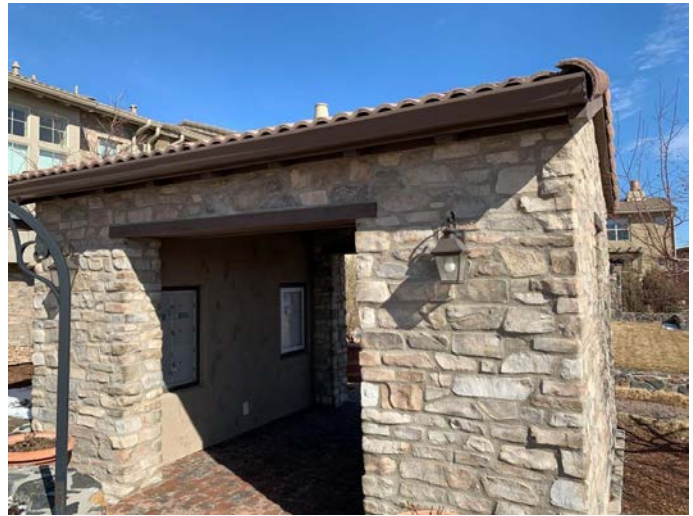
Comp #: 309 Stone - Major Repairs

- Typically, these stones have an extended life expectancy and complete replacement is unlikely.
- There are times where some stones will loosen and fall off, but this is unpredictable when and how much would occur.
- Repairs should be handled as a maintenance issue on an as needed basis at this time.
- If it later turns out that frequent repairs are necessary, then funding could be added in future Reserve Study updates.

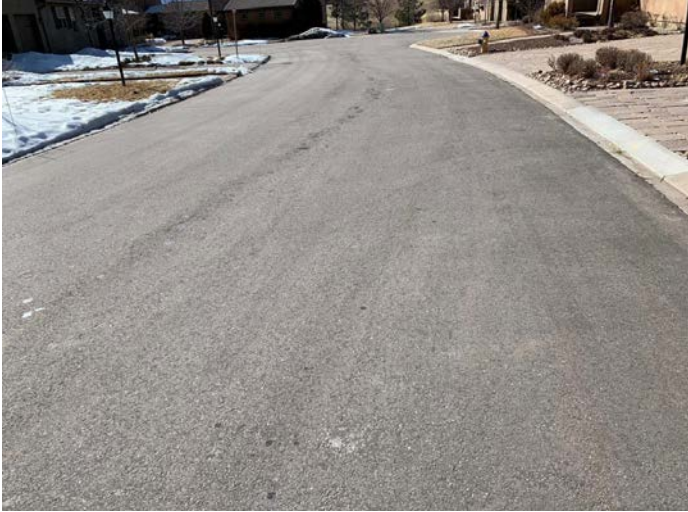
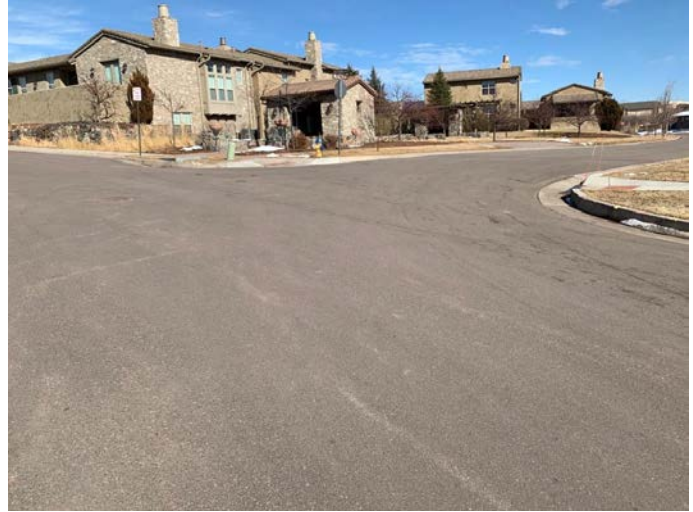
Comp #: 401 Asphalt - Major Overlay

- The streets were repaired and new asphalt was installed on all streets and the large parking area off of Palazzo Grove.
- The average life expectancy for asphalt surfaces ranges between 20 - 27 years for surfaces that are maintained on a regular schedule.
- Maintenance includes crack fill and repairing small potholes annually as an operating expense.
- In addition, asphalt should be treated every 3 - 5 years, depending on the level of traffic and snow removing techniques.

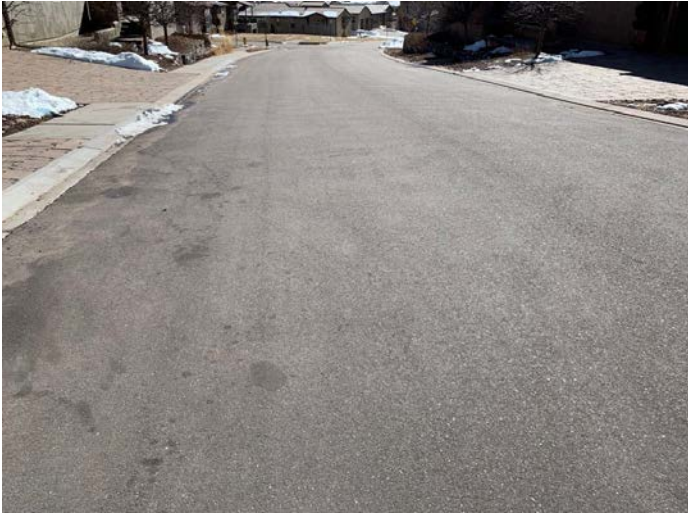
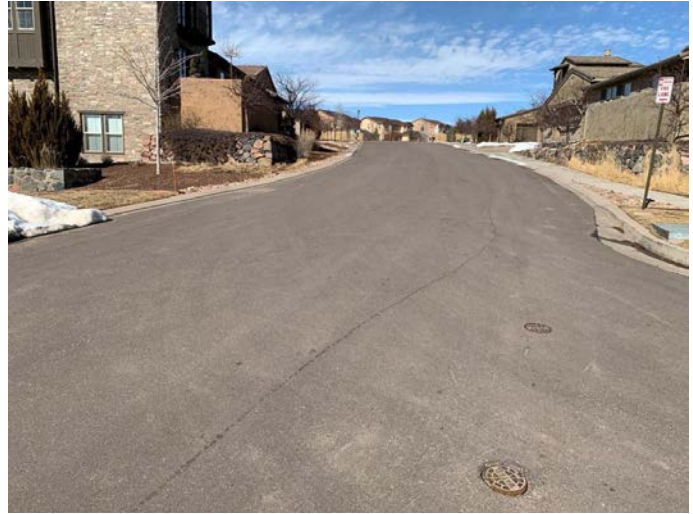
Comp #: 402 Asphalt - Surface Application

- Surface treatments are used to extend the useful life of asphalt and to help maintain aesthetics; there are a broad range of products to choose from so we recommend consulting a reputable contractor for your community's needs.
- The recommendation is an allowance for the mid range surface treatments that are available in today's market.
- Expect to seal coat, chip seal or slurry seal your asphalt every 3 - 5 years, as the asphalt ages it may be necessary to adjust the frequency and or cost of these projects.

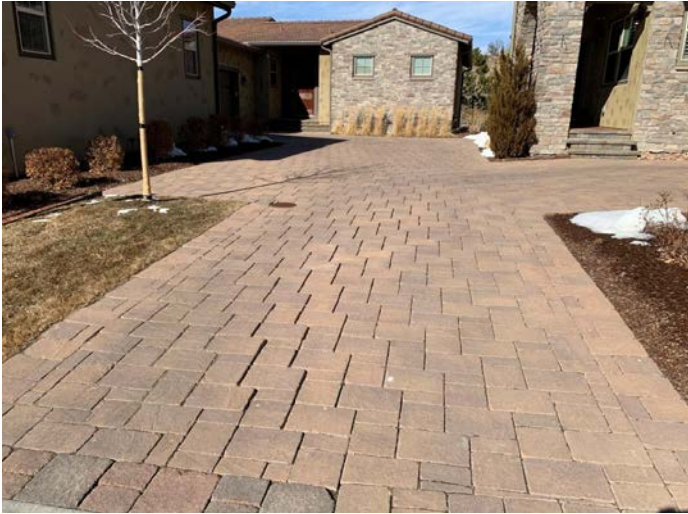
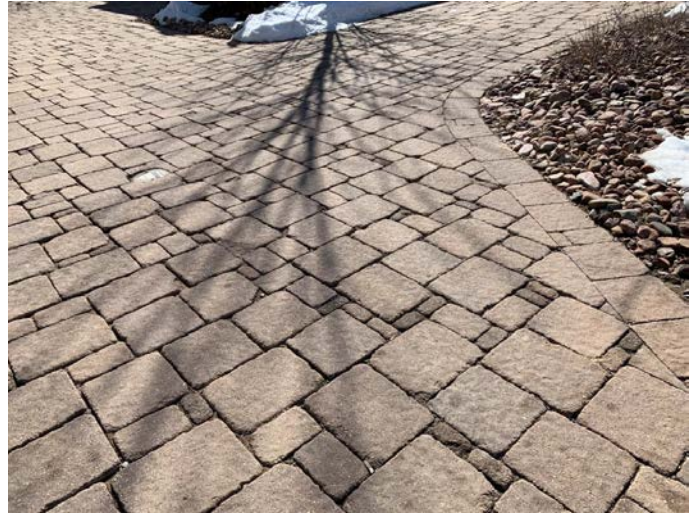
Comp #: 404 Brick Pavers Drive - Repair/Replace

- No expectation to completely replace pavers.
- Reserve to periodically repair 5% to prevent extensive settling and level out uneven areas every 5 years.

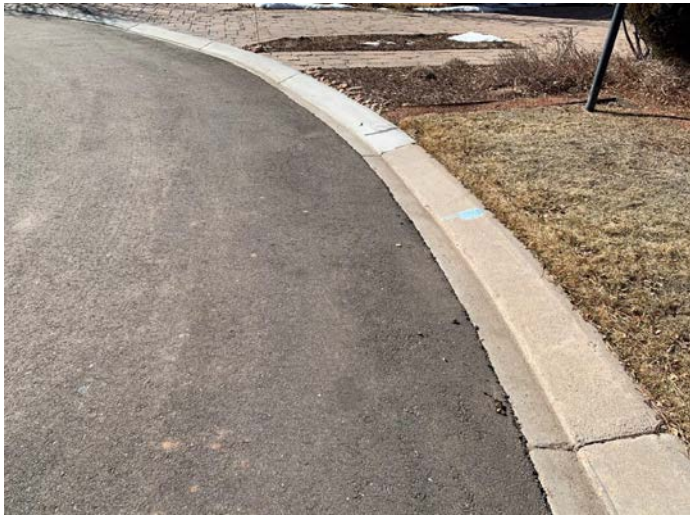
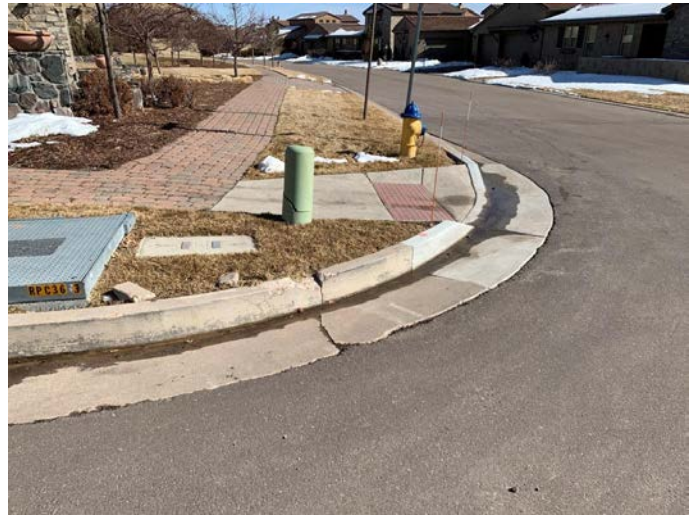
Comp #: 407 Curb and Gutters/Drain Pan - Partial Replace

- Since it is unlikely all surfaces will need to be replaced at the same time, we suggest establishing a Reserve fund to repair 10% of the area (660 GSF) every 5 years.
- Coordinate future repairs with asphalt work for best cost estimate since most asphalt companies can also perform concrete repairs.

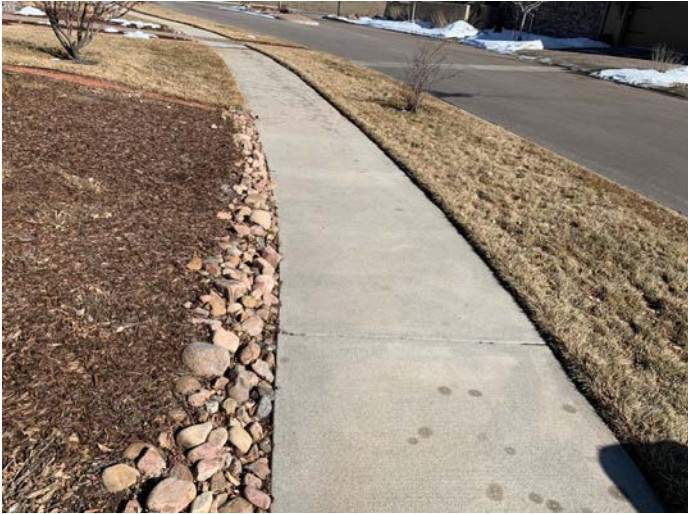
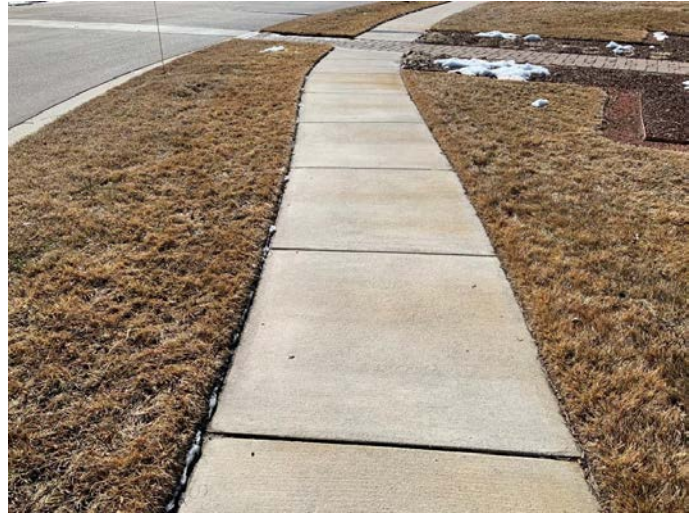
Comp #: 601 Concrete Flatwork - Partial Replace

- Similar to other concrete surfaces, it is unlikely that all concrete surfaces will fail and need to be replaced at the same time.
- Therefore, we suggest establishing a Reserve fund for frequent repairs and replacement to a percentage of the area (20% or 650 GSF) every 5 years.
- Coordinate repairs with other concrete surfaces for best cost estimate.

3631: Approx. 60 GSF
Palazzo Grove: Approx. 1,235 GSF
Tuscanna: Approx. 1,480 GSF
3775: Approx. 100 GSF - Some settling on sidewalk
Bocce Ball Court: Approx. 380 GSF

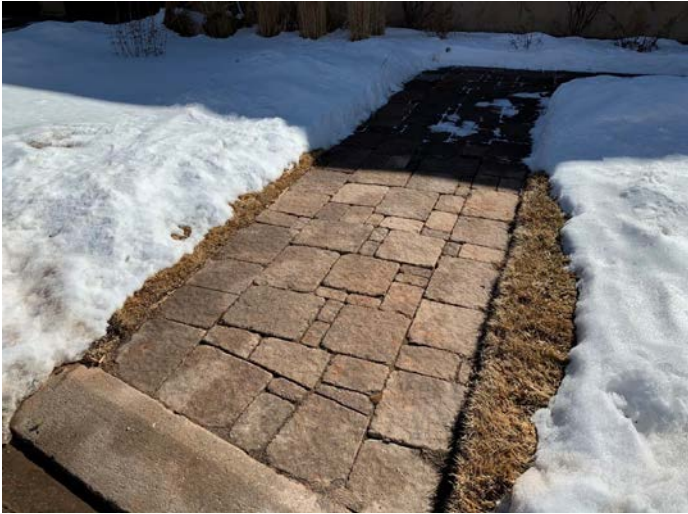
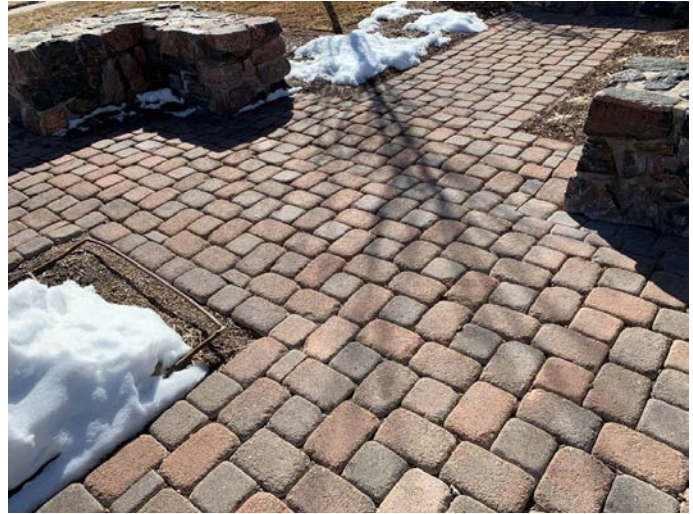
Comp #: 602 Brick Paver Sidewalks - Repair

- This type of walkway is subject to shifting and settling, which can result in tripping hazards.
- Being a public access area, it is very important to maintain a level surface at all times.
- Therefore, we have established a line item for periodic inspections and repairs to maintain a safe surface at all times.
- Timing has been scheduled to coordinate with paved driving surfaces for best cost since contractor will be on site at the same time.

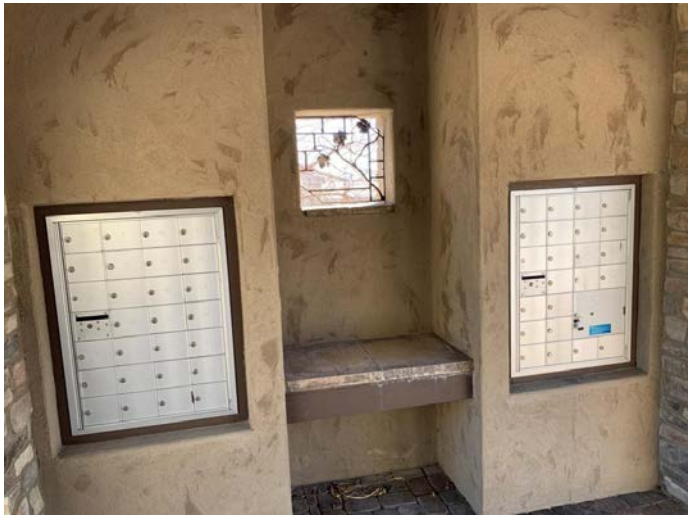
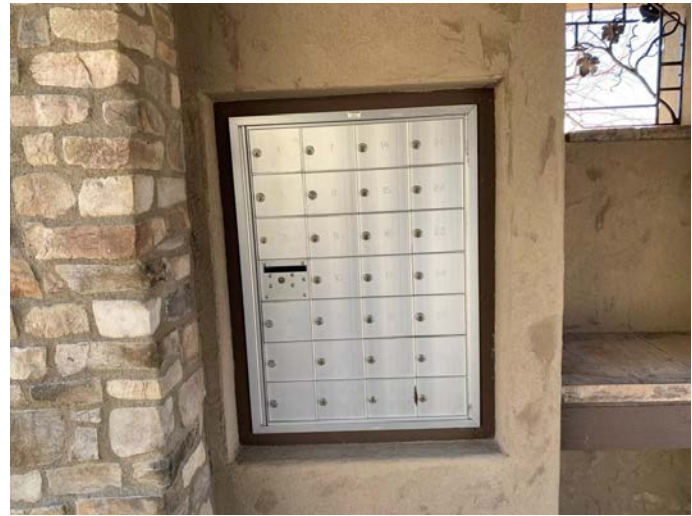
Comp #: 803 Mailboxes - Replace

- According to several manufacturers, the typical life expectancy for this type of mailbox is 15 - 20 years in this environment.
- However, these units are protected from many of the elements, so a longer useful life is expected.
- Remaining life is based on average age of all units.
- Per new Postal regulations effective 2012, "all customers are responsible for repairs and replacement of keys, locks, or the boxes/cluster units themselves".

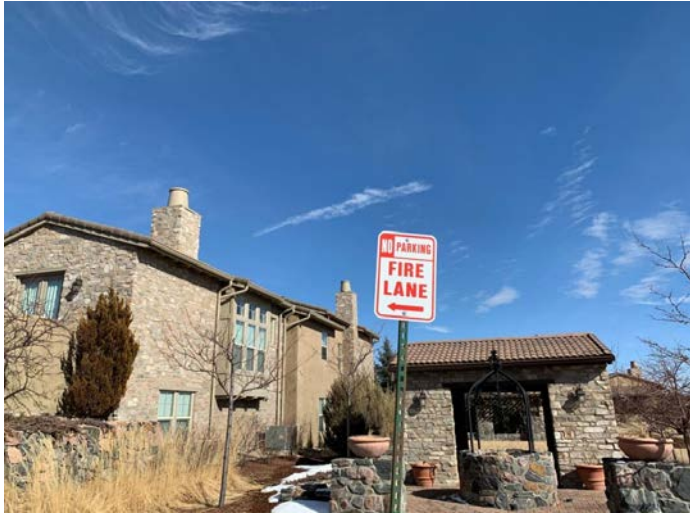
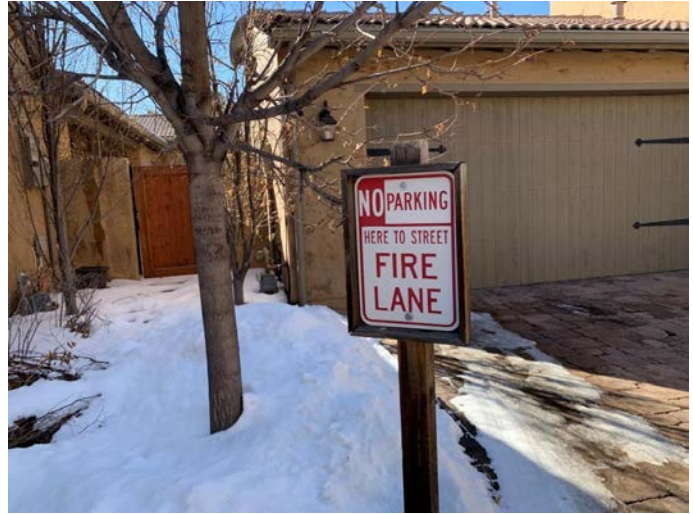
Comp #: 808 No Parking Signs - Replace

- Due to the low quantity and relatively small replacement cost, we recommend addressing any repairs and replacement on an as needed basis with general operating funds.
- Therefore, at this time, separate Reserve funding is not required for this component

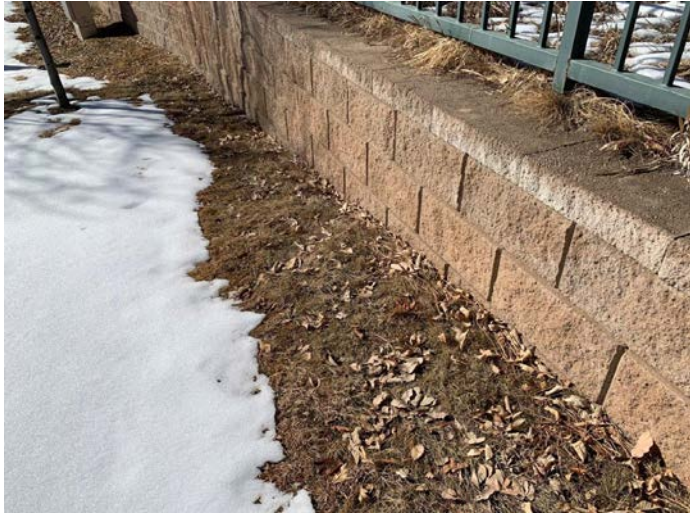
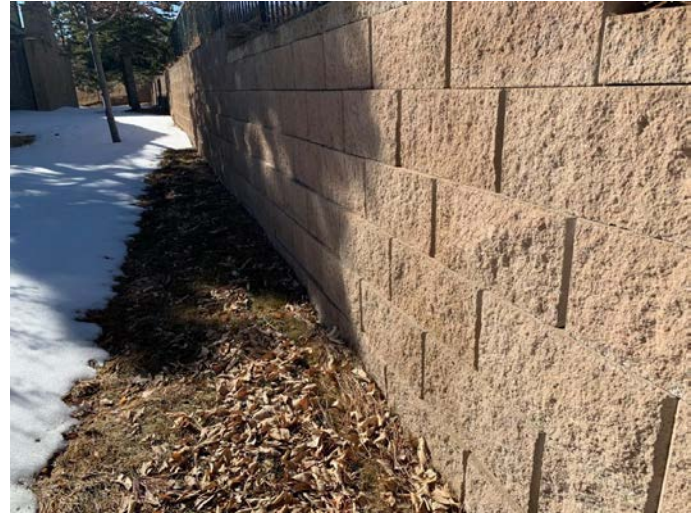
Comp #: 1005 Block Wall - Replace

- The block wall appeared to be in good condition.
- As long as block wall was installed conforming to county code, this wall should have an extended useful life.
- Since there is no expectation to replace wall, Reserve funding is not required for this component.

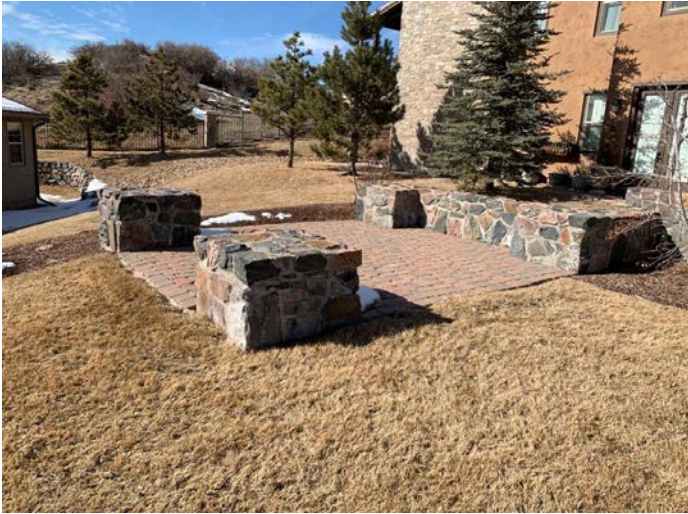
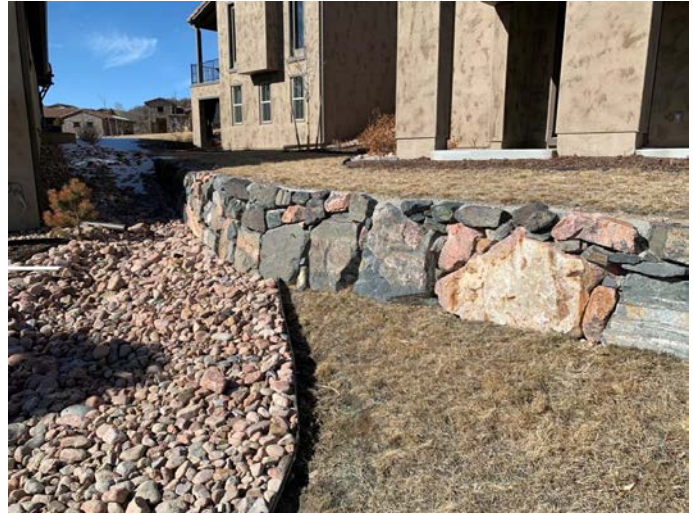
Comp #: 1013 Stone Wall - Major Repairs

- While it is unlikely that the entire wall will need to be replaced, it is likely that major repairs will be necessary to replace loose or missing stones.
- Depending on the effects from weather, we suggest establishing a Reserve fund for periodic repairs to the walls every 10 years.
- Remaining life is based on observed condition and estimated timing of when repairs may be required.

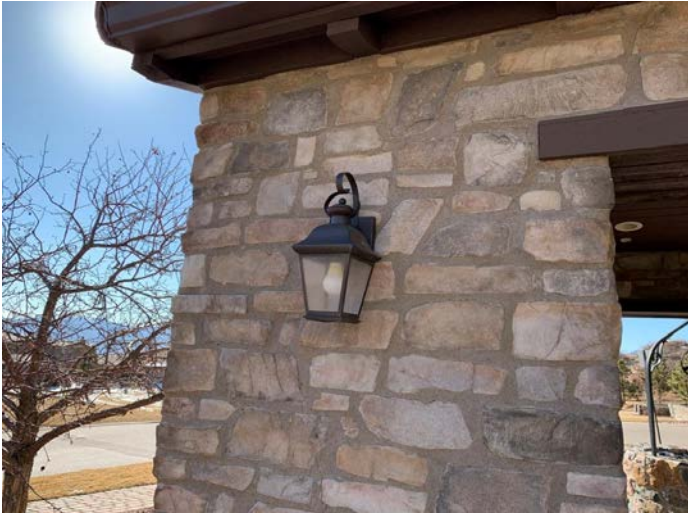
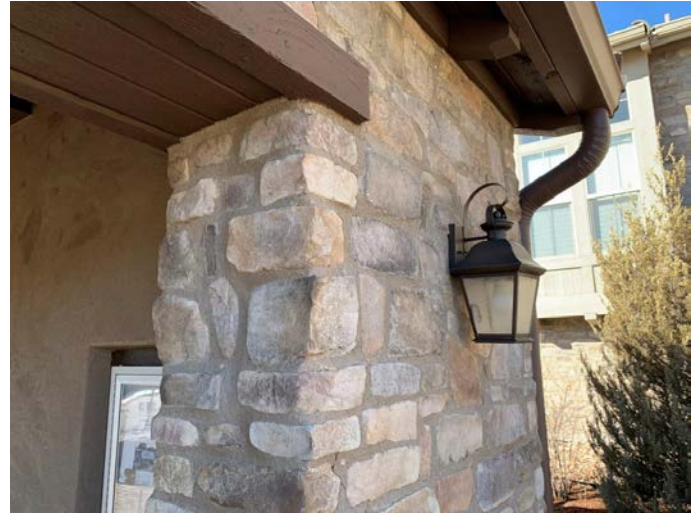
Comp #: 1602 Exterior Wall Mount - Replace

- Due to the minimal cost to replace these lights, Reserve funding is not appropriate.
- Repair and replace as necessary as an operating expense.

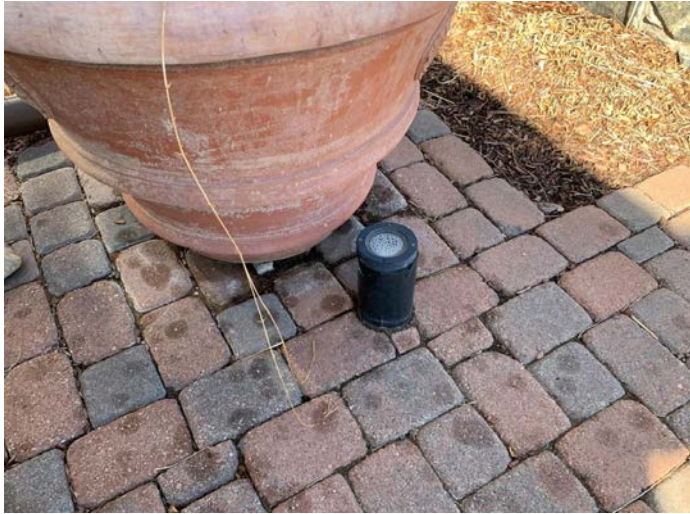
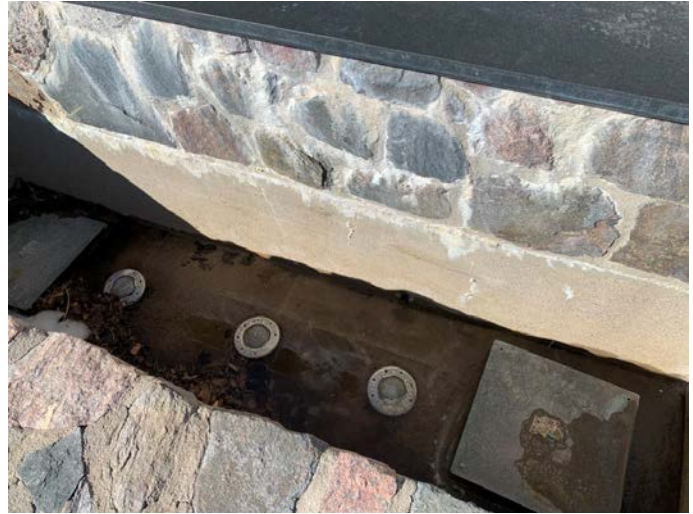
Comp #: 1603 Landscape Lights - Replace

- No expectation to replace all lights at one time.
- We suggest replacing fixtures on an individual basis as necessary as an operating issue.
- Therefore, Reserve funding is not required at this time.

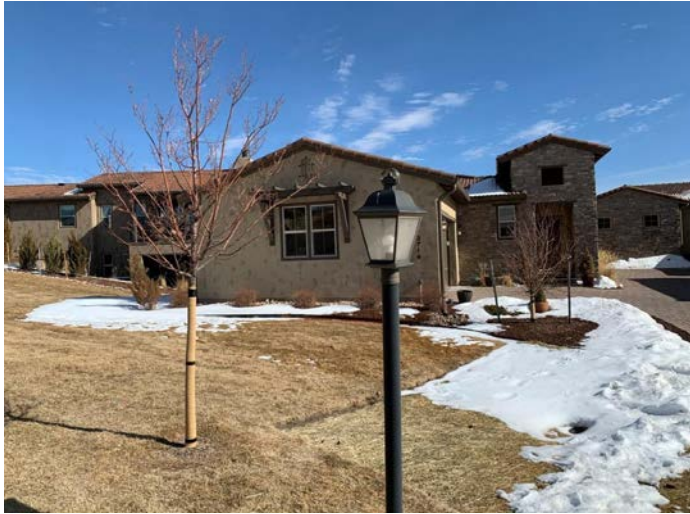
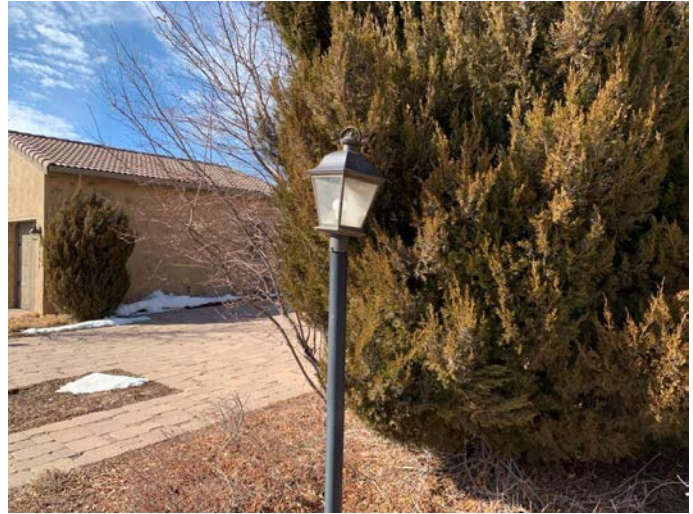
Comp #: 1604 Pole Lights - Replace

- No reported problems with electrical issues or malfunctioning lights
- Reserve to replace fixtures on a 20 year schedule to maintain appearance and function.

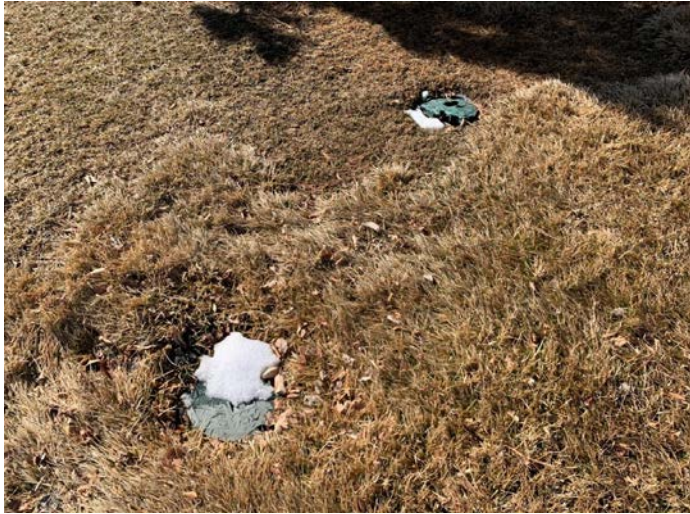
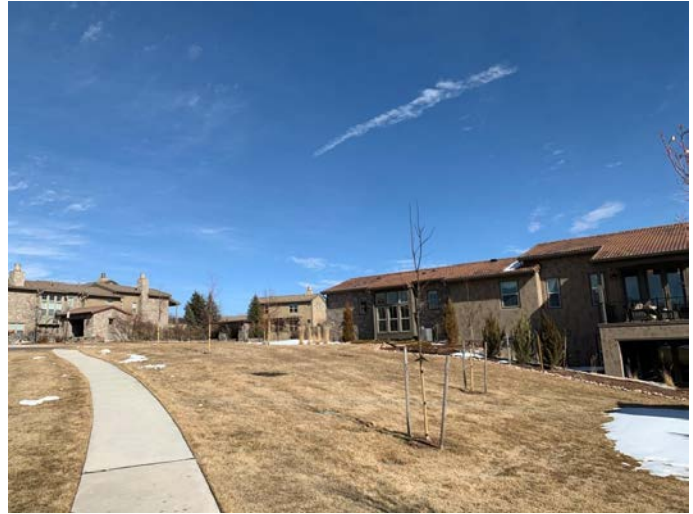
Comp #: 1701 Irrigation System - Rebuild

- This line item is for repairs and replacement that lies outside the scope of routine maintenance: bulk sprinkler head replacement, bulk valve replacement, rerouting lateral lines, rewiring, etc.
- In order to ensure the funds are available for major repairs, we recommend reserving funds for these projects every 4 - 5 years.
- The funding on this line item is for major repairs and is not to be interpreted as complete irrigation system replacement.

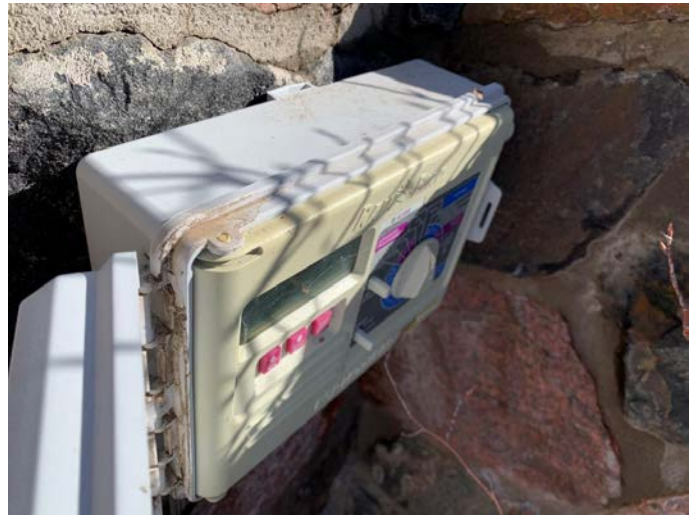
Comp #: 1703 Irrigation Controllers - Replace

- The overall life expectancy of irrigation controllers typically ranges between 10 - 12 years if properly maintained and under normal conditions.
- Remaining life is based on the age of the controllers.

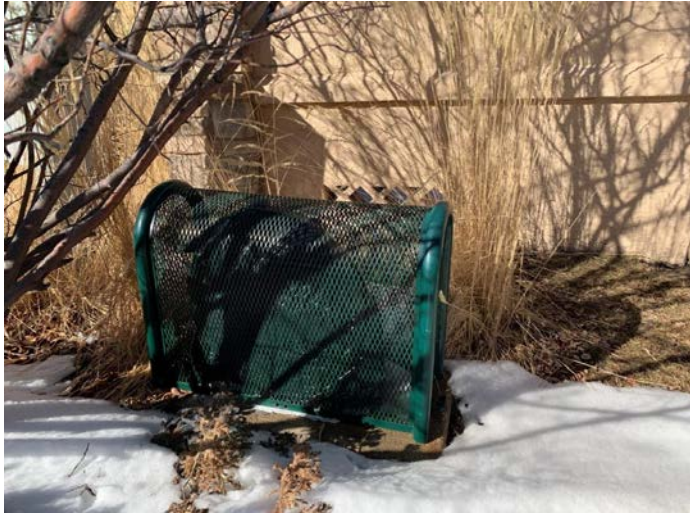
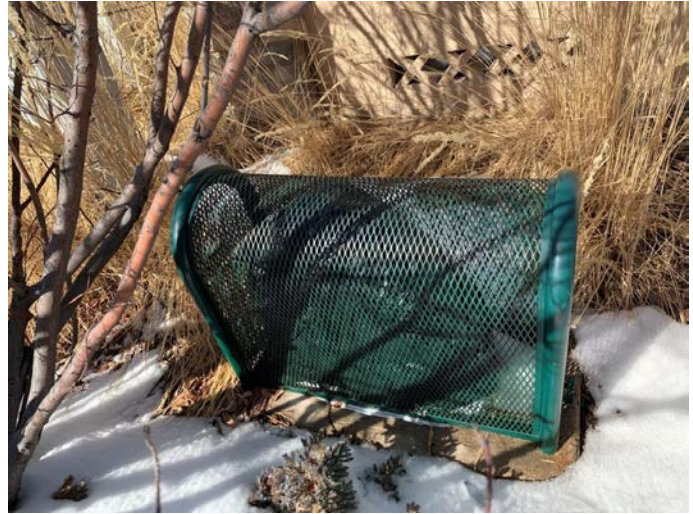
Comp #: 1706 Backflow Devices - Replace

- Devices can be rebuilt and repaired when needed as a maintenance issue.
- It is very seldom that a complete system would need to be replaced due to normal wear and tear.
- Replacement would be as a result of freezing conditions if system is not winterized properly or in a timely manner.
- No Reserve funding is required due to difficulty of predicting a life expectancy and the fact that systems can be rebuilt at a minimal cost, as opposed to being replaced.

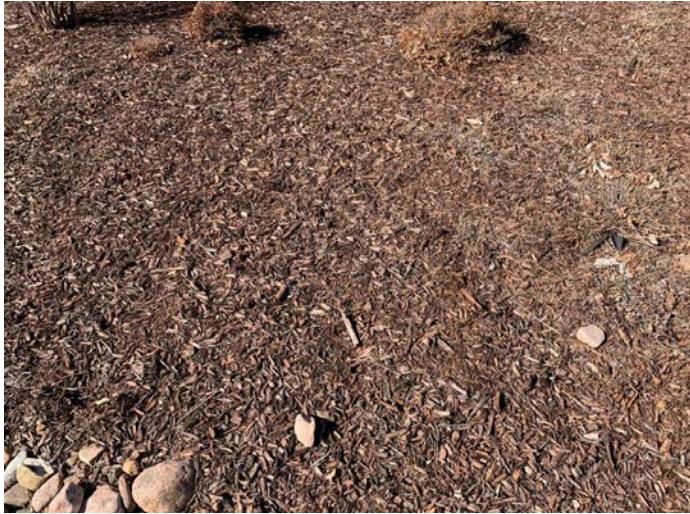
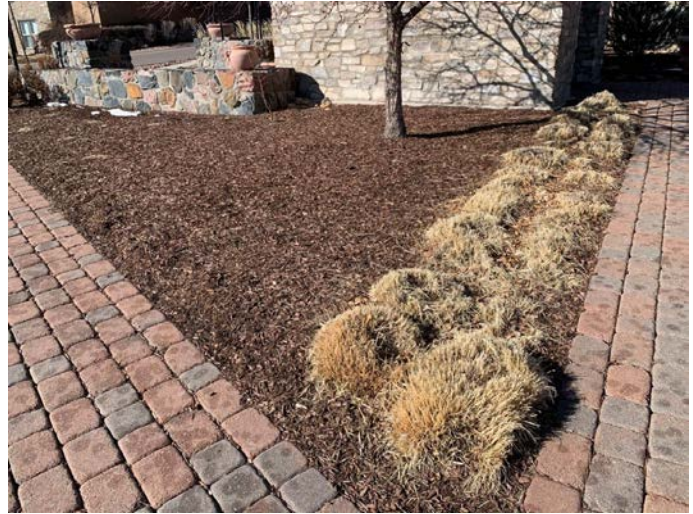
Comp #: 1801 Groundcover - Replenish

- This line item, similar to irrigation repairs, is for projects that lie outside the scope of routine maintenance.
- In order to preserve an attractive curb appeal and to maintain the health of the plants and shrubs, we recommend reserving for refurbishment projects every 2 - 4 years.
- This line item is for cyclical refurbishment and should not be considered as complete landscaping replacement.

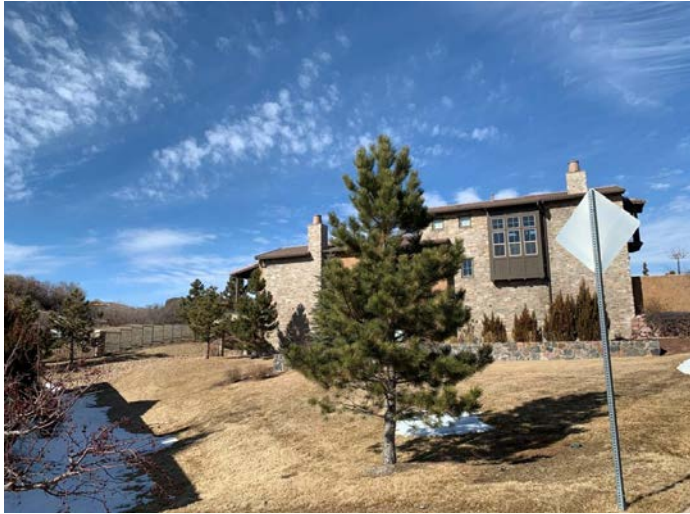
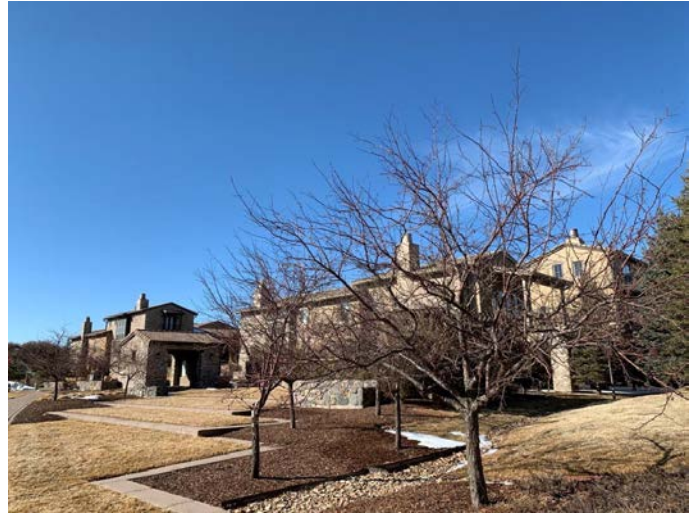
Comp #: 1804 Tree - Replacement/Major Maintenance

- It is very difficult to predict a replacement cycle for trees as there are several factors such as disease, infestation of insects, heavy snow storms, etc. can all attribute to eventual tree replacement.
- Since it is difficult to predict when the replacement will be necessary, Reserve funding is typically not a factor.
- Therefore, unless requested by the association, Reserve funding will not be included as part of the study for this component.

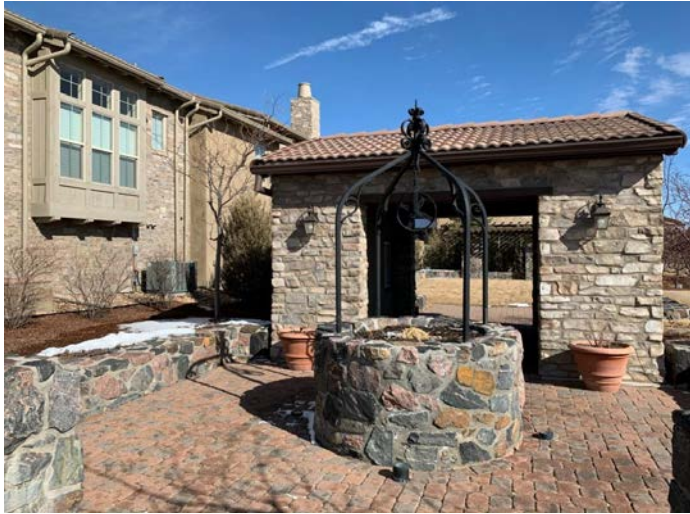
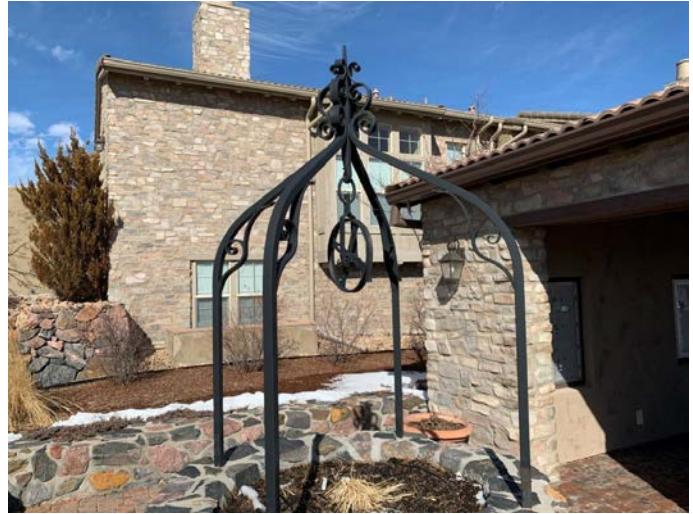
Comp #: 2005 Iron Wishing Well - Replace

- These materials typically have an indefinite life expectancy.
- Due to the minimal amount of material and extended life expectancy, Reserve funding is not required at this time.

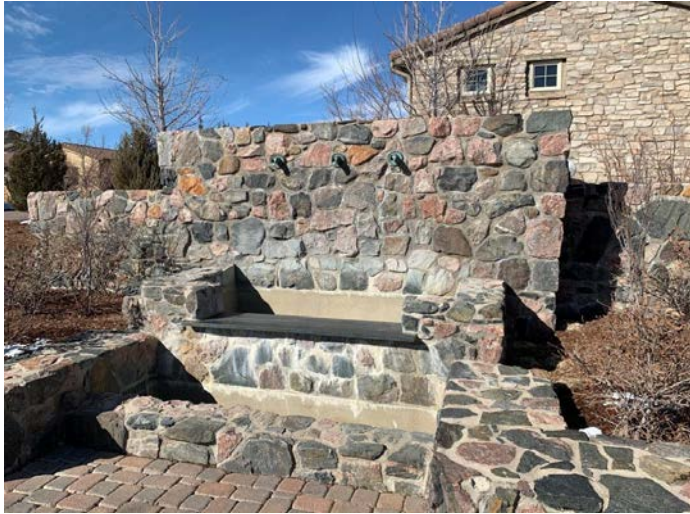
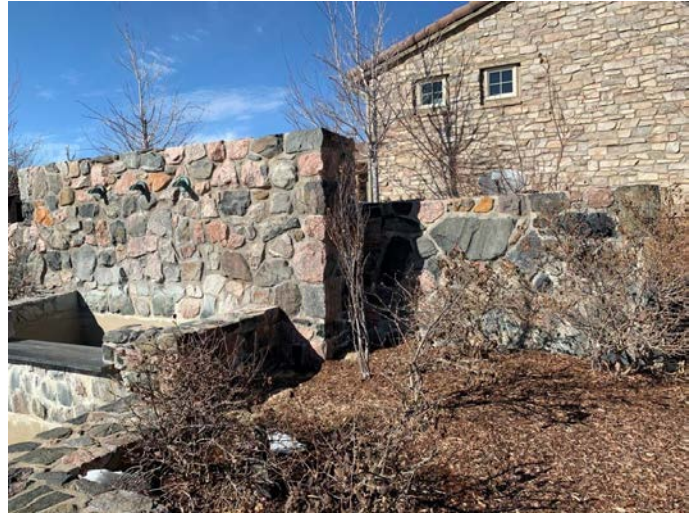
Comp #: 2007 Water Feature - Major Repairs

Location: **By Community Entrance**

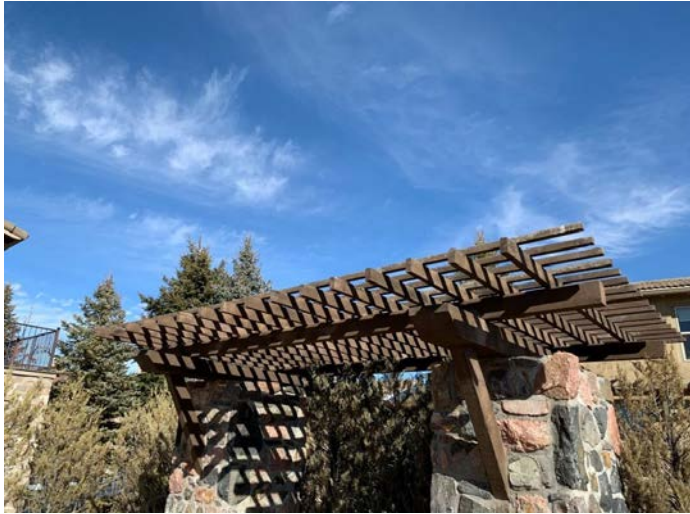
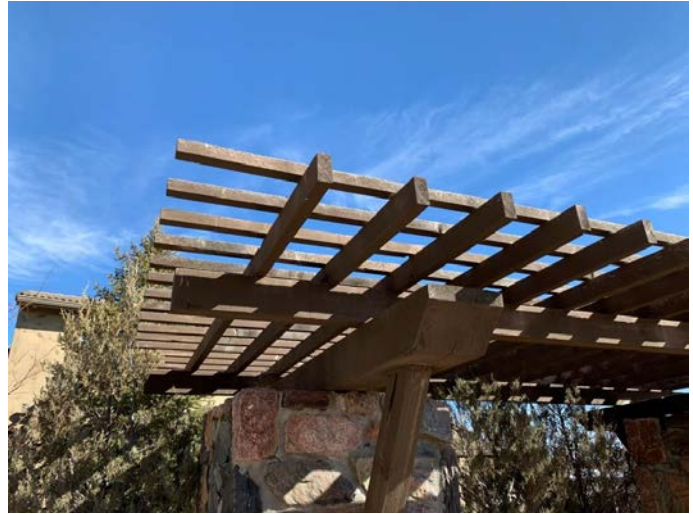
Comp #: 2020 Wood Trellis - Replace

- It was noted that it needs to be restained.
- Staining will extend the life expectancy of the structure.
- Remaining life based on observed condition.

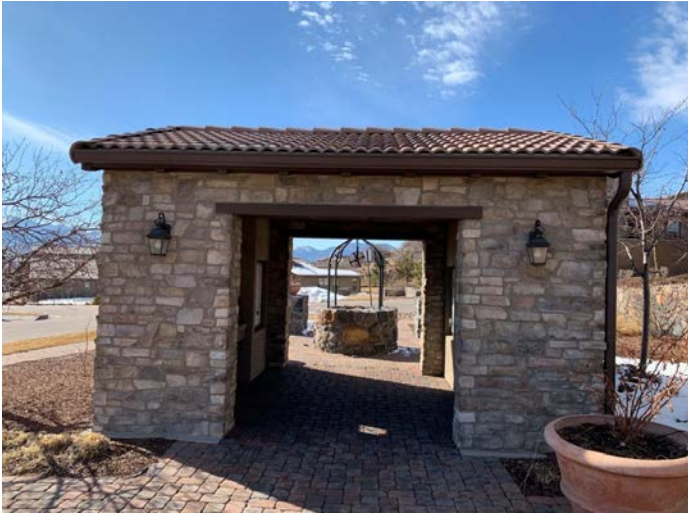
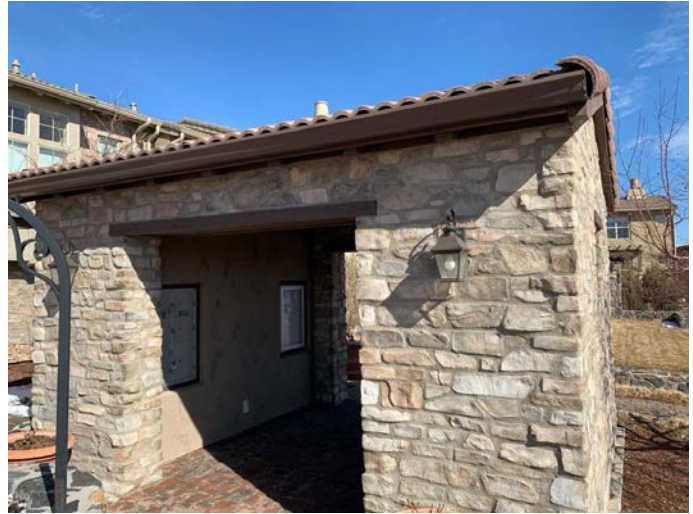
Comp #: 2020 Mailbox Structure - Major Repairs

- The mailbox structure appeared to be in good condition during the site observation.
- This line item is for major repairs to the structure, not complete replacement.
- Remaining life based on observed condition.
