Level 2, Premium Reserve Analysis

# Carriages Neighborhood at Pine Creek Village 2655 Pine Knoll View Colorado Springs, CO. 80920

## FINAL VERSION

Date of Property Observation – January 14, 2020

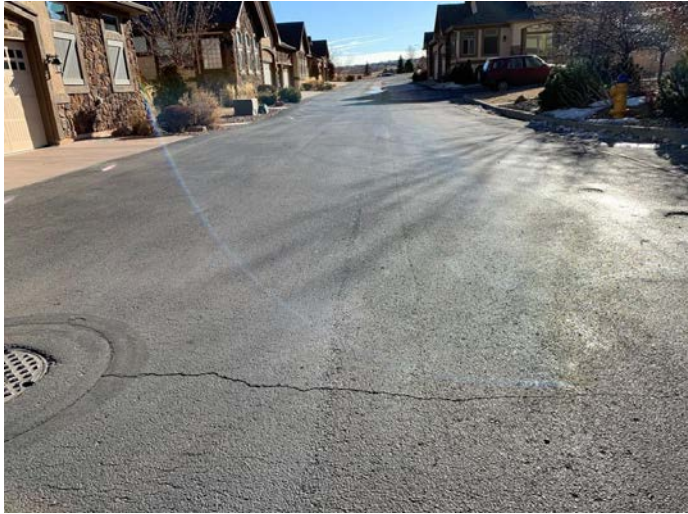
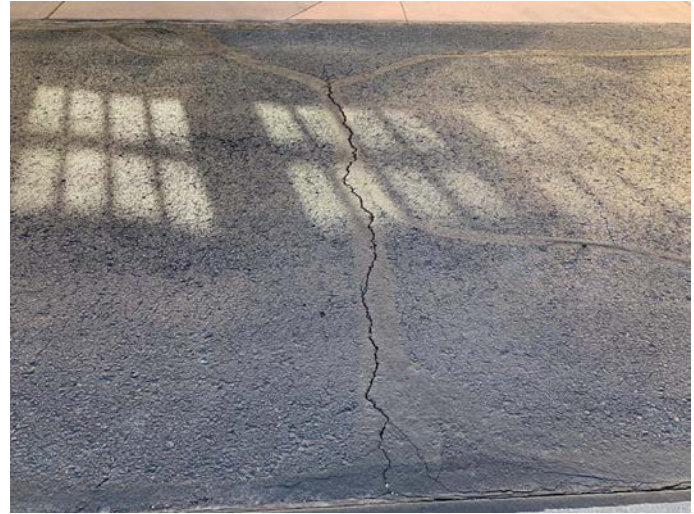
Comp #: 401 Asphalt - Overlay

- The average life expectancy for asphalt surfaces ranges between 20 - 27 years for surfaces that are maintained on a regular schedule.
- Maintenance includes crack fill and repairing small potholes annually as an operating expense.
- In addition, asphalt should be seal coated every 3 - 4 years, depending on the level of traffic and snow removing techniques.

**Life Expectancy:** **24** Remaining Life: **11**

Est. to rotomill and 2" overlay

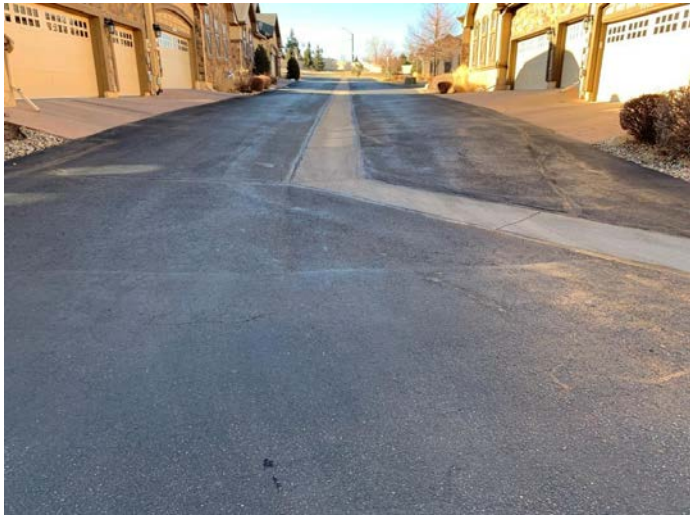
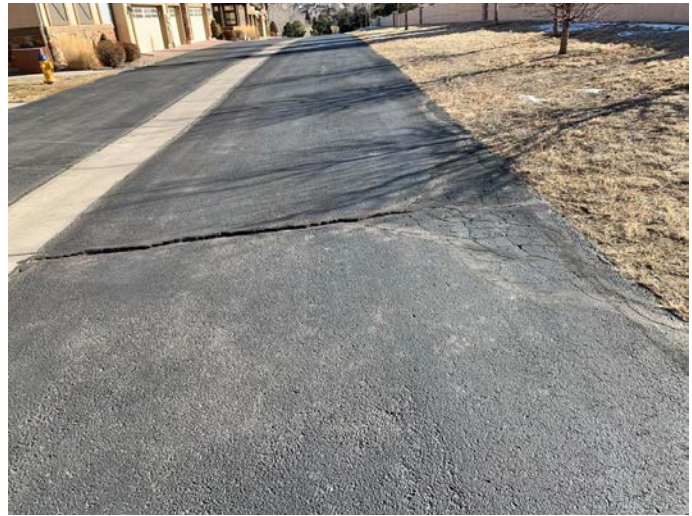
Comp #: 402 Asphalt - Seal Coat/crack fill

- In this environment, expect to seal asphalt every 2 - 4 years, depending on traffic levels and effects from weather.
- Seal coating is applied to protect the asphalt from ultra-violet rays and water.
- This helps in slowing the process of oxidation and raveling.
- While acting as a protective barrier, it also maintains the appearance of the community to maintain or improve property values.

**Life Expectancy:** **3** **Remaining Life:** **1**

Estimate for seal coat only

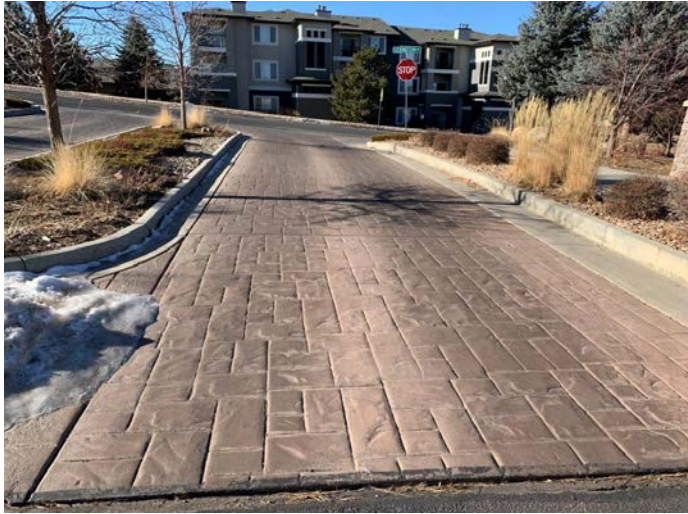
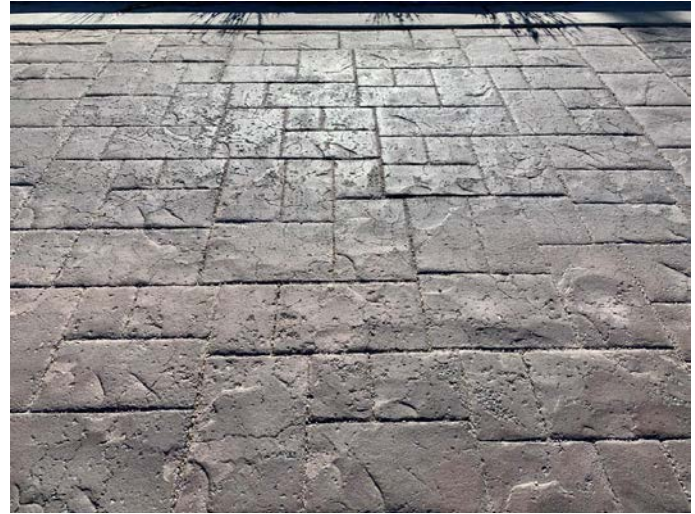
Comp #: 405 Stamped Concrete - Repair/Replace

- While periodic repairs are a possibility, with repairs to stamped concrete, it is difficult to match the design of the original stamp and the color.
- Therefore, we recommend complete replacement of the driveway every 20 - 25 years. We suggest coordinating this to occur at the same time as asphalt work for best cost estimate.

*Life Expectancy:* **24** *Remaining Life:* **11**

\$15.00/GSF; Estimate to replace

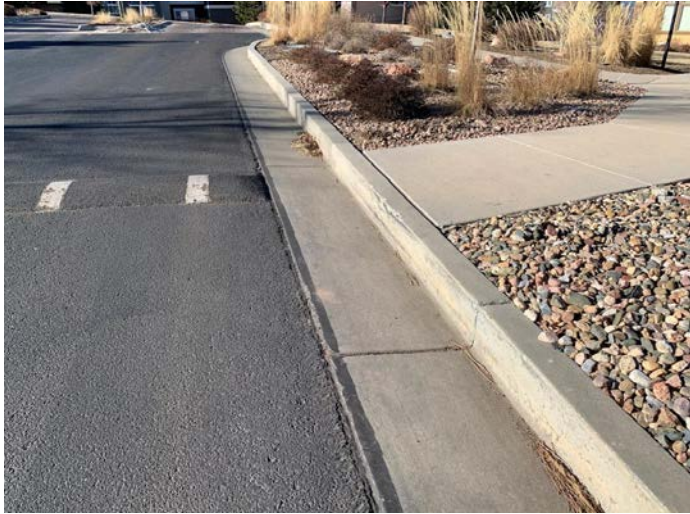
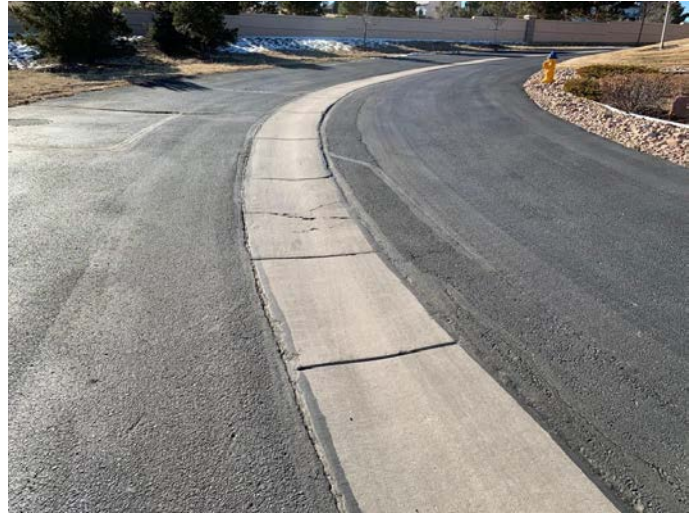
Comp #: 407 Curbs/Gutters/Drain Pans - Repair

- Since it is unlikely all surfaces will need to be replaced at the same time, we suggest establishing a Reserve fund to repair 15% of the area (1,350 GSF) every 6 years.
- Coordinate future repairs with asphalt work for best cost estimate since most asphalt companies can also perform concrete repairs.

Estimate to repair 15% of area every 6 years

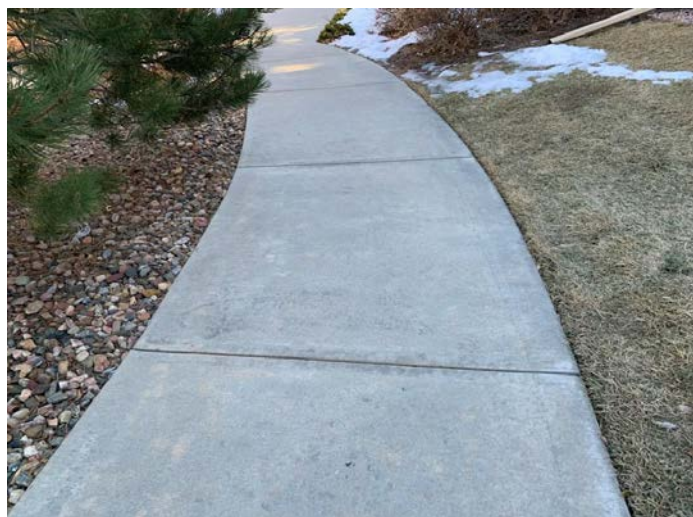
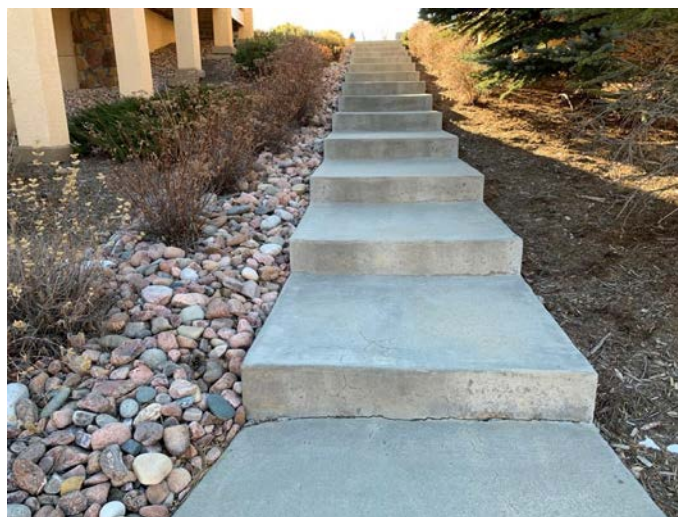
Comp #: 601 Concrete Sidewalks/Decks - Repair

- Similar to other concrete surfaces, it is unlikely that all concrete surfaces will fail and need to be replaced at the same time.
- Therefore, we suggest establishing a Reserve fund for frequent repairs and replacement to a percentage of the area (15% or 1,500 GSF) every 6 years.
- Coordinate repairs with other concrete surfaces for best cost estimate.

Estimate to replace 15% of area every 6 years

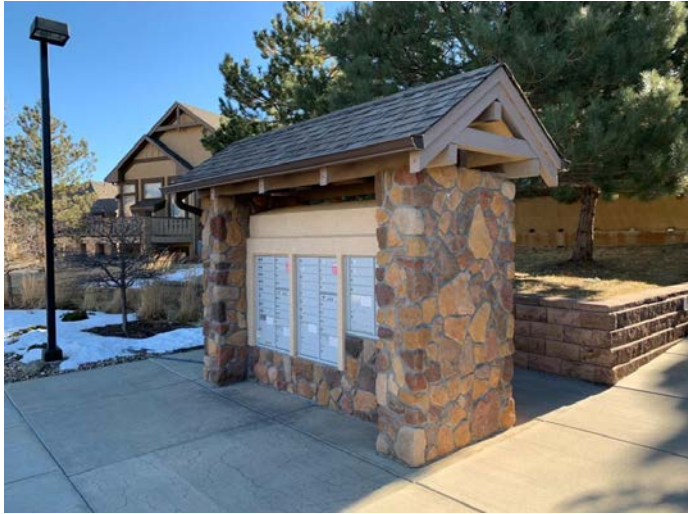
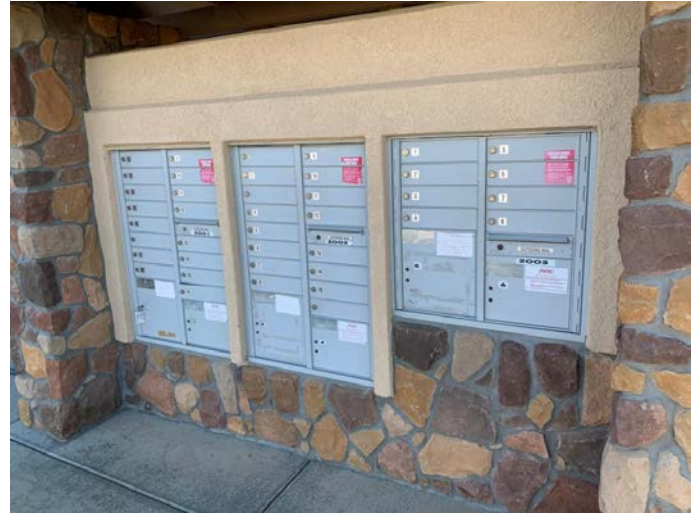
Comp #: 803 Mailboxes/Structure - Replace

- It was reported the boxes and structure are the responsibility of the Pine Creek Village master Association.
- Therefore, separate Reserve funding is not required for this component.

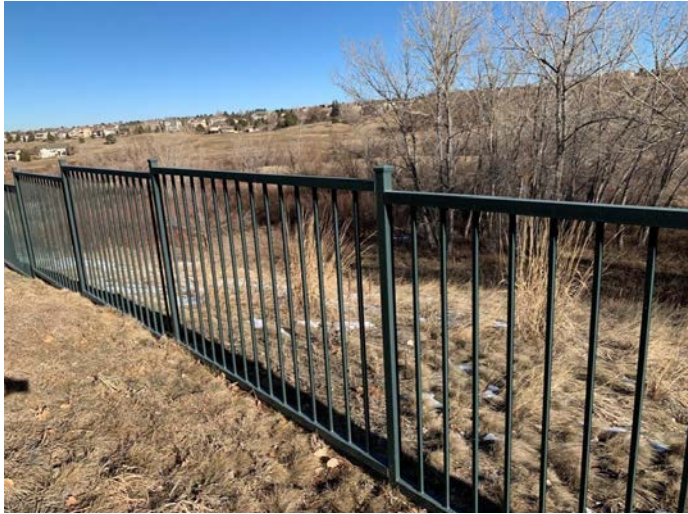
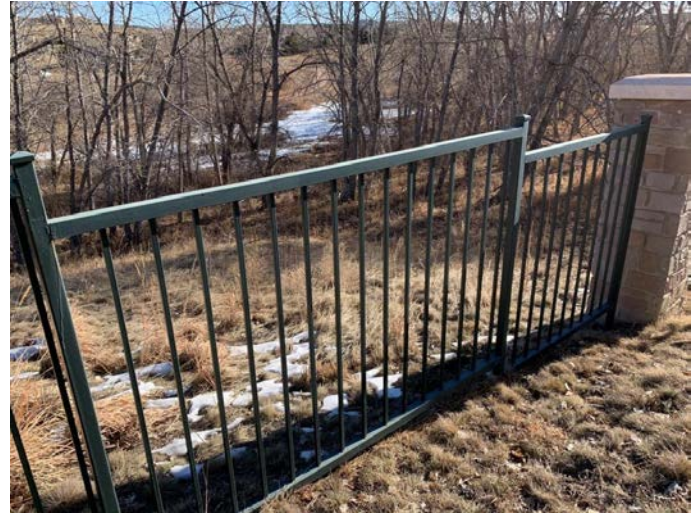
Comp #: 1002 Perimeter Fence - Replace

- It was reported in the original Reserve Study that this fence is the responsibility of the master association to maintain, not Carriages Neighborhood.
- Therefore, Reserve funding is not included in this report for eventual replacement or maintenance.
- This line item is provided for future reference to Board members, community managers, and Reserve professionals.

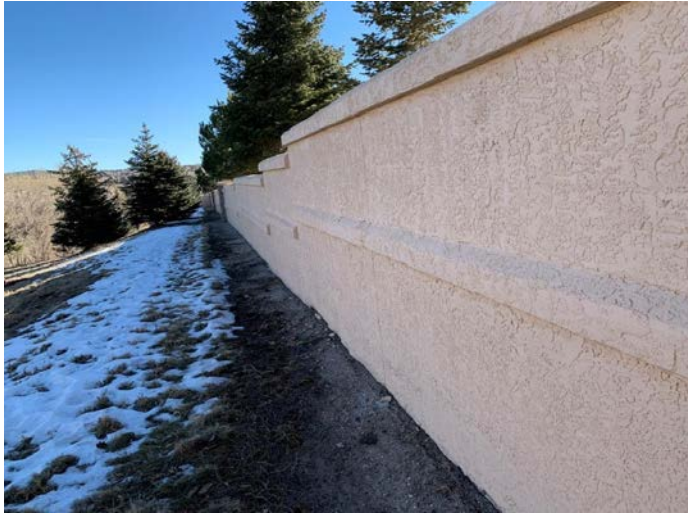
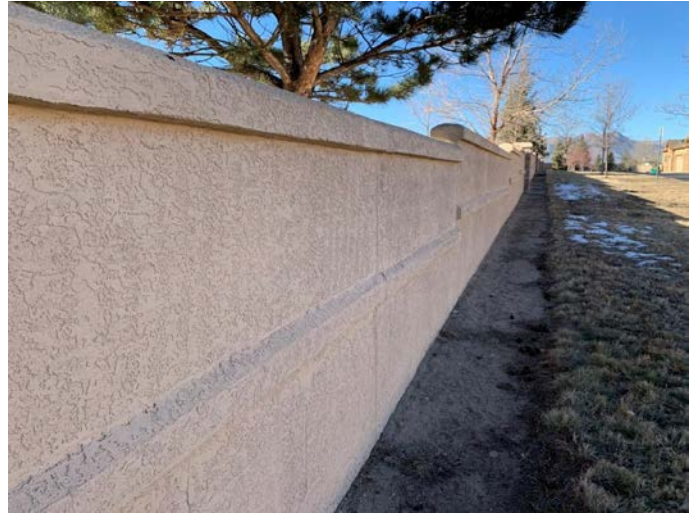
Comp #: 1005 Stucco Wall - Replace

- Similar to iron fence, it was reported that this wall is the responsibility of the master association.
- Therefore, separate Reserve funding is not required for this component.
- This line item is provided for future reference to Board members, community managers, and Reserve professionals.

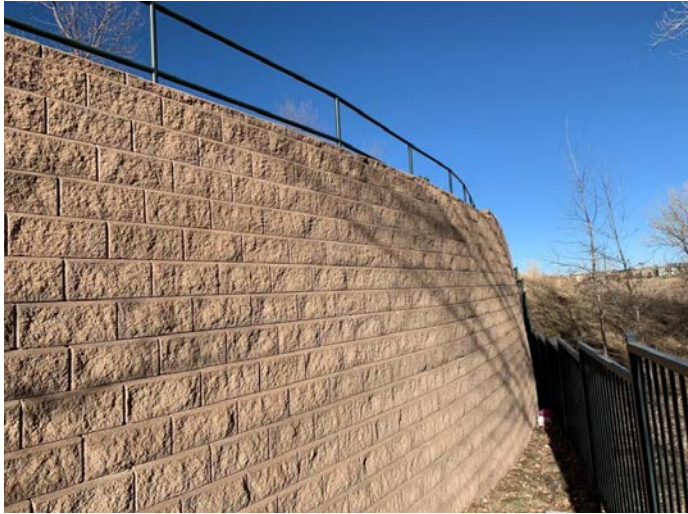
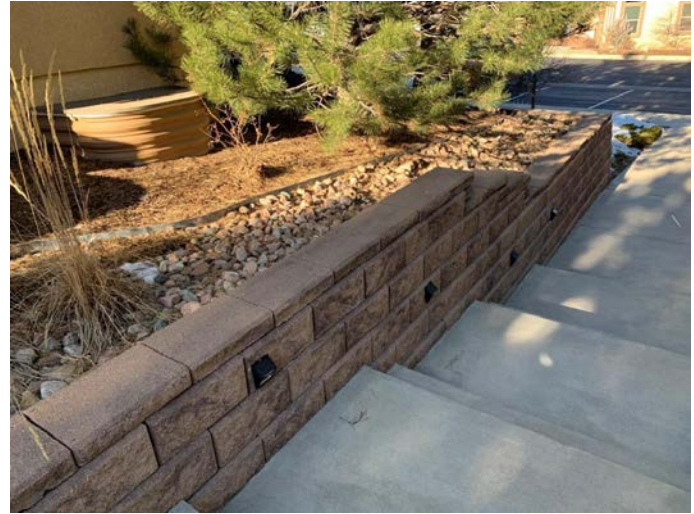
Comp #: 1011 Retaining Walls - Replace

- As long as block wall was installed conforming to county code requirements, this wall should have an extended useful life.
- This type of material has an indefinite life expectancy and complete replacement is unlikely.
- Therefore, Reserve funding is not required for this component.

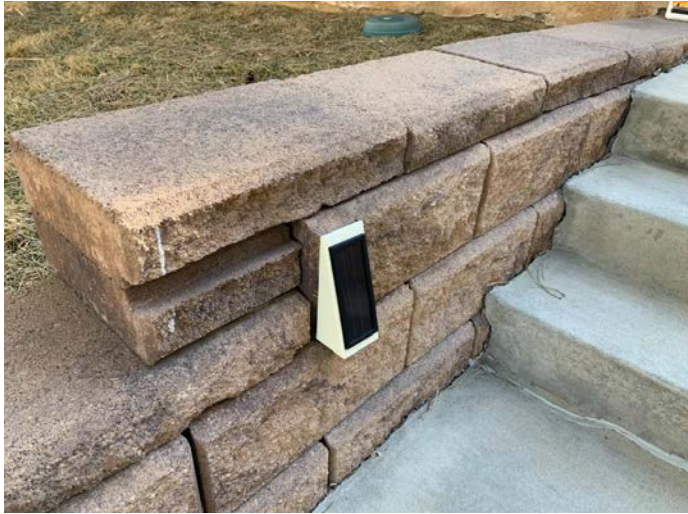
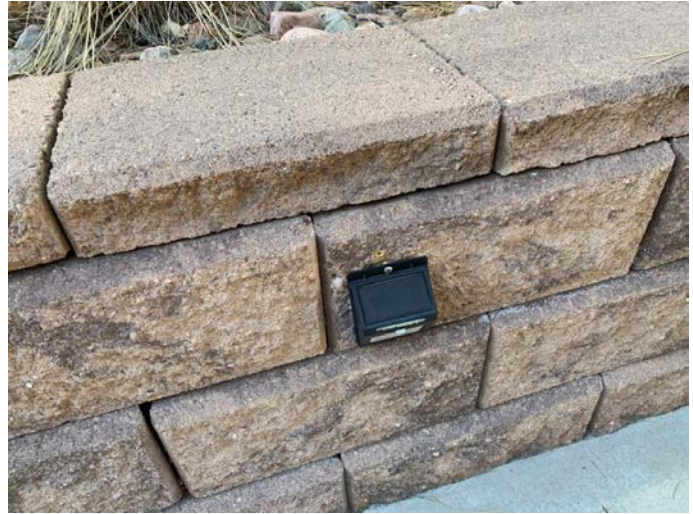
Comp #: 1602 Solar Wall Lights - Replace

- It is assumed these were added for safety reasons for the steps leading to and from the mailboxes.
- Due to the low replacement cost associated with these lights, we recommend replacing on an as needed basis with general operating funds.

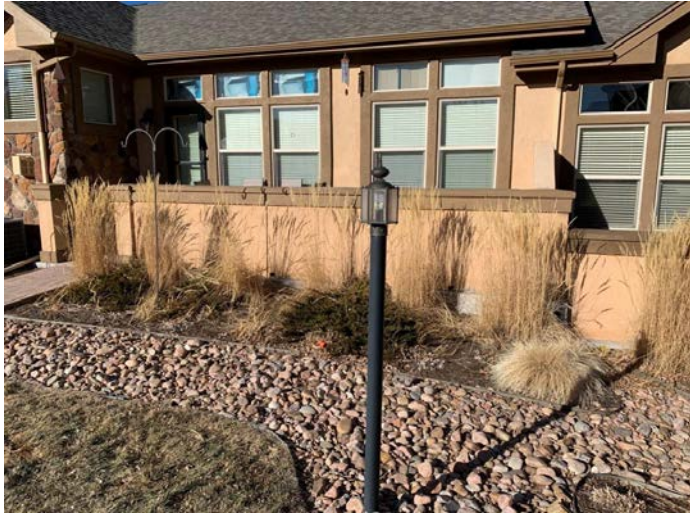
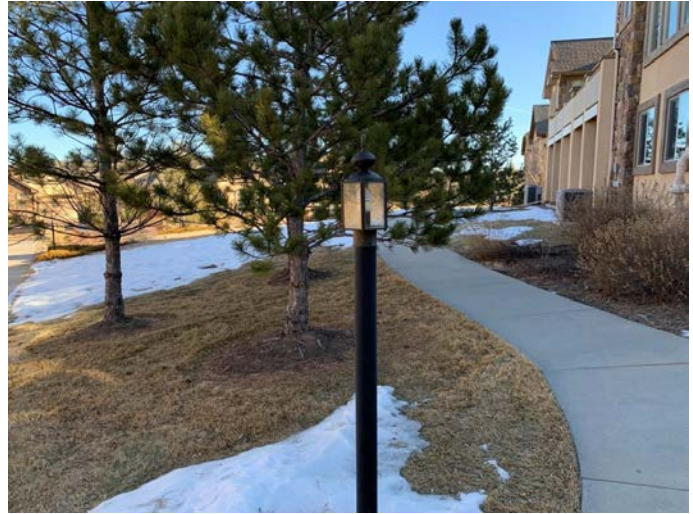
Comp #: 1604 Pole Lights - Replace

- Paint these pole lights regularly to prevent rust damage and ensure full life.
- Expect to replace these lights approximately every 17 - 20 years to maintain appearance and function.
- Remaining life is based on age and observed conditions.

\$425/fixture; Estimate to replace heads

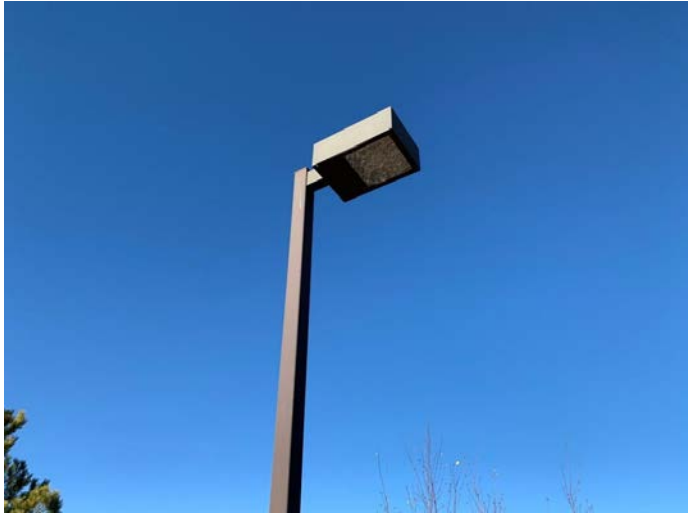
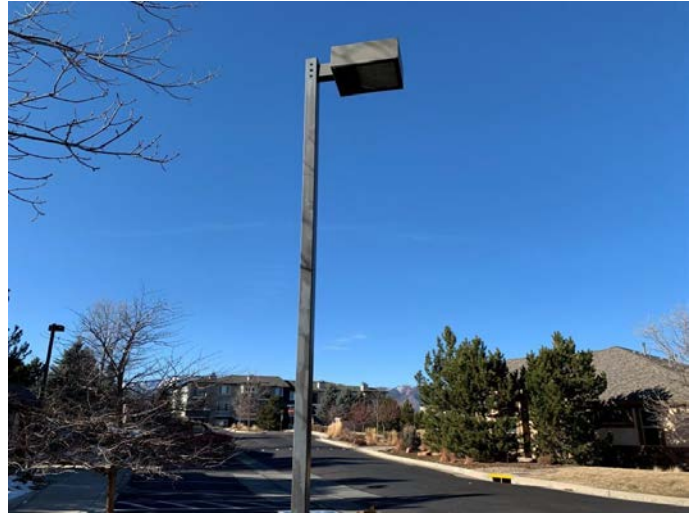
Comp #: 1609 Street Lights - Replace

- The average replacement cycle for this type of light ranges between 25 - 30 years. Remaining life is based on the average age and observed condition.
- Depending on the level of deterioration, periodically, the heads of the fixtures could be replaced instead of the entire pole and fixture.

\$3,150/light; Estimate to replace

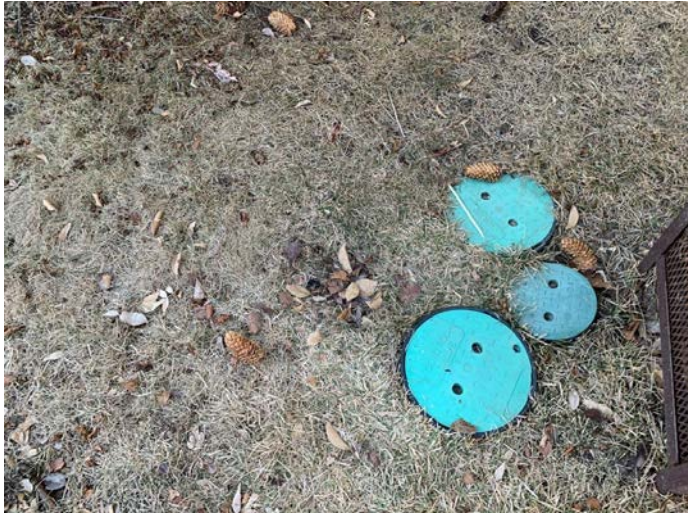
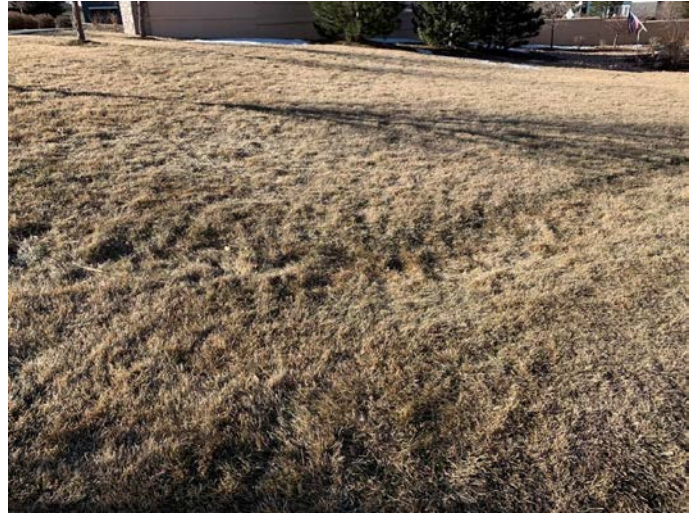
Comp #: 1701 Irrigation System - Major Repairs

- This line item is for repairs and replacement that lies outside the scope of routine maintenance: bulk sprinkler head replacement, bulk valve replacement, rerouting lateral lines, rewiring, etc.
- In order to ensure the funds are available for major repairs, we recommend reserving funds for these projects every 6 - 8 years.
- The funding on this line item is for major repairs and is not to be interpreted as complete irrigation system replacement.

Estimate for major repairs

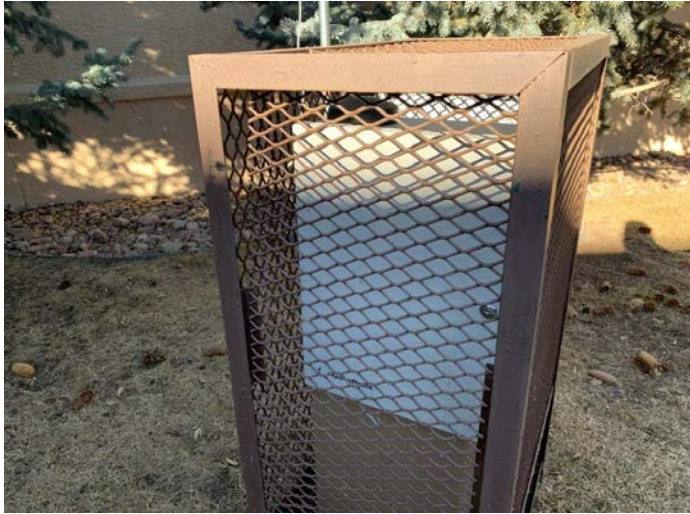
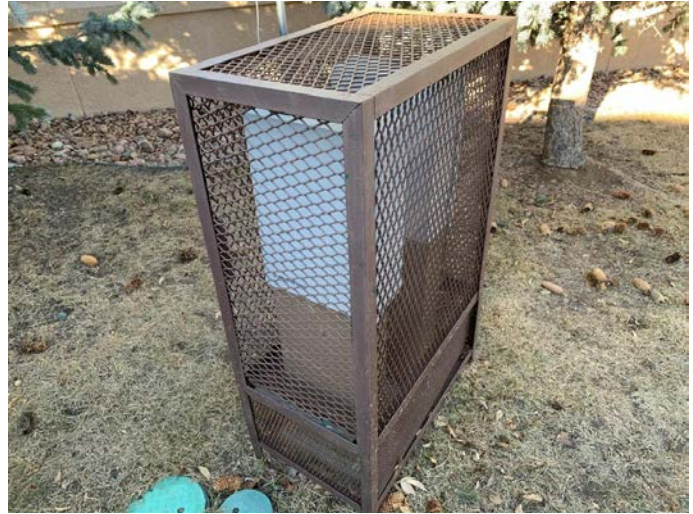
Comp #: 1703 Irrigation Controllers - Replace

- These clocks are an ET system that provides higher water efficiency to the system.
- Like other controllers, under normal conditions (not including Acts of God, vandalism, etc.) these clocks should last 10 - 12 years with proper maintenance.
- The remaining life is based on the approximately age of the controller.

\$5,750/clock; Estimate to replace

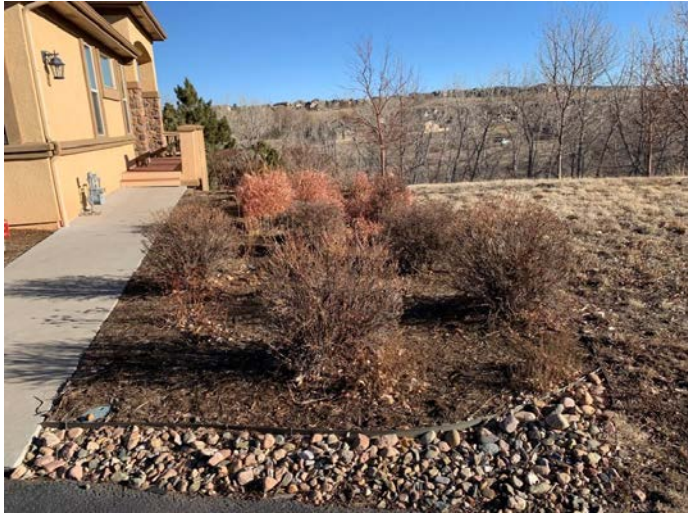
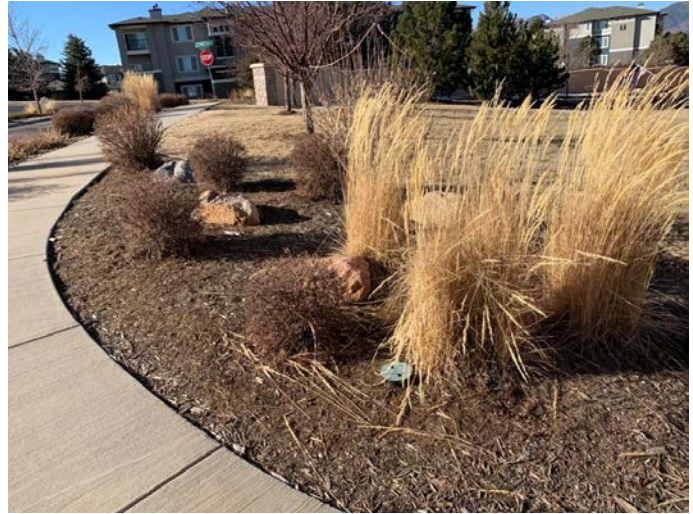
Comp #: 1801 Groundcover - Replenish

- This line item, similar to irrigation repairs, is for projects that lie outside the scope of routine maintenance.
- In order to preserve an attractive curb appeal and to maintain the health of the plants and shrubs, we recommend reserving for refurbishment projects every 2 - 3 years.
- This line item is for cyclical refurbishment and should not be considered as complete landscaping replacement.

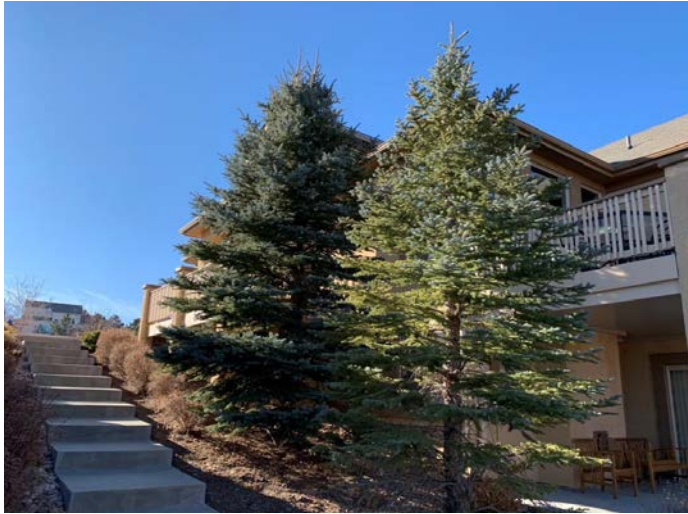
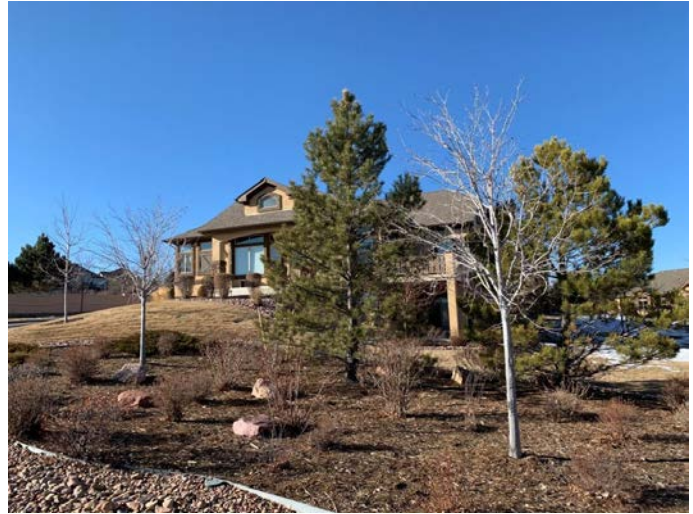
Comp #: 1804 Tree - Replacement

- It is very difficult to predict a replacement cycle for trees as there are several factors such as disease, infestation of insects, heavy snow storms, etc. can all attribute to eventual tree replacement.
- Since it is difficult to predict when the replacement will be necessary, Reserve funding is typically not a factor.
- Therefore, unless requested by the association, Reserve funding will not be included as part of the study for this component.

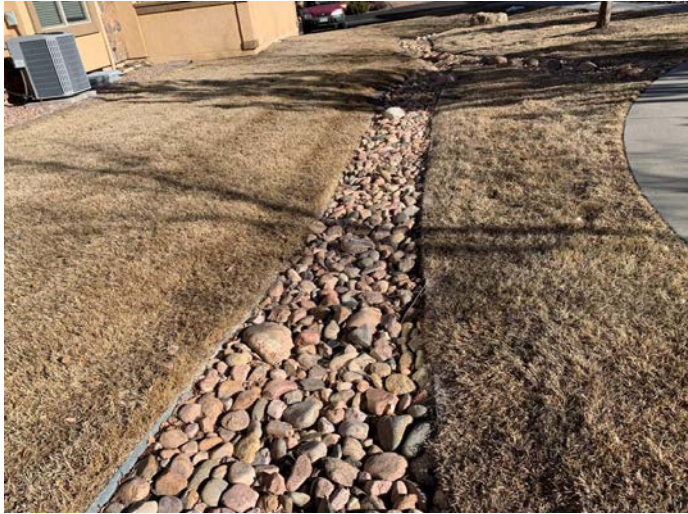
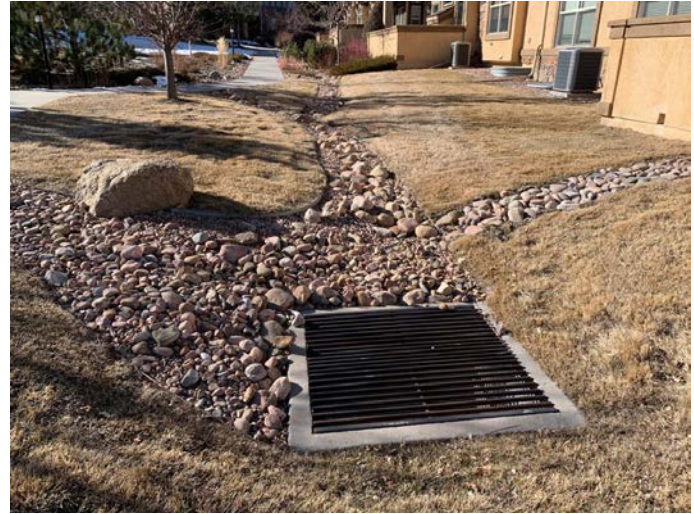
Comp #: 2003 Underground Drainage

- It is difficult to predict a life expectancy for this component. We suggest inspecting the drain lines at least once every 3 years to ensure there are no blockages, or potential blockages.
- If there are potential problems, then clean out the lines on an as needed basis with general operating funds.
- In the future, if frequent major repairs and/or maintenance is required, then Reserve funding can be added in future Reserve Study updates as an item based on historical information.
