**Reverie at Pine Creek Village
3073 Sovereign View
Colorado Springs, CO 80920**

Level 1 Reserve Analysis

Report Period – 01/01/15 – 12/31/15

**Final
Report**

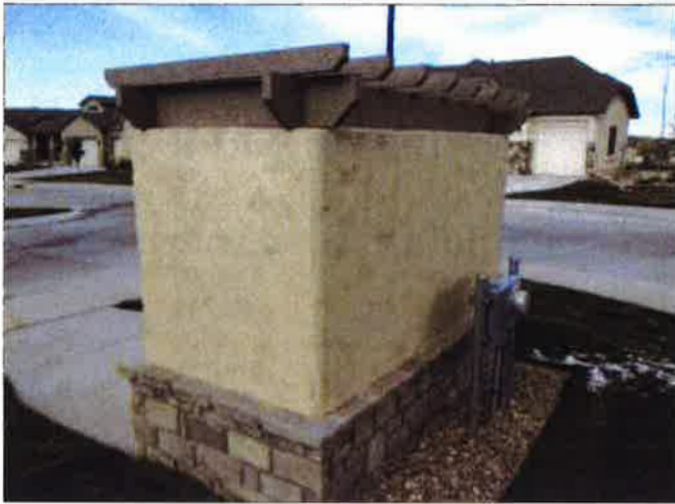
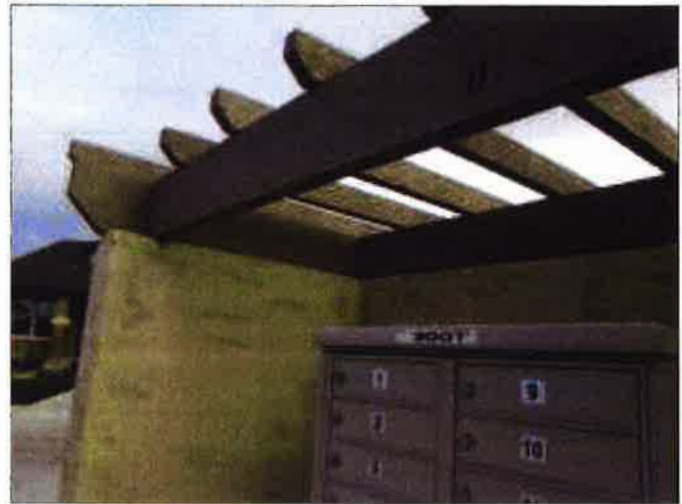
Comp #: 2020 Mailbox Structure - Major Repairs

* Some damage to paint from hail storm, but no other damage was noted. Stucco, stonework, and wood cross members were in good condition with no advanced deterioration noted.

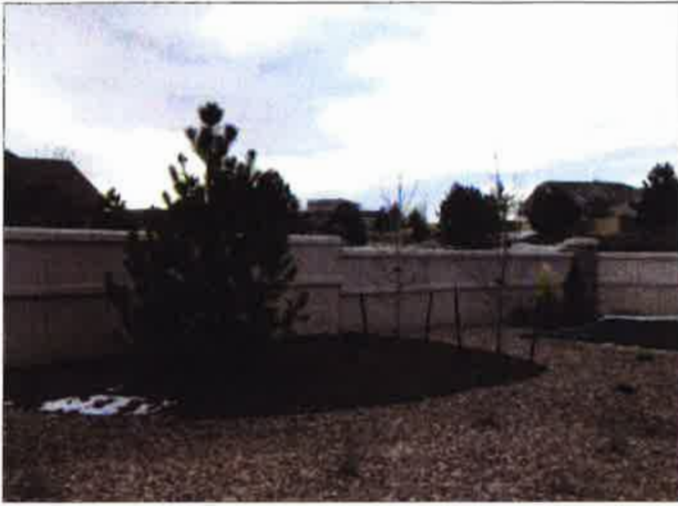
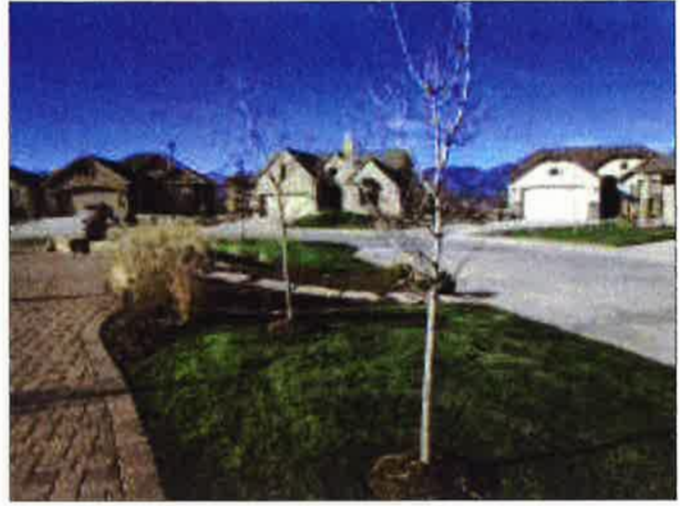
Comp #: 1804 Tree - Replacement

- * Trees appeared to be healthy and in good condition at time of site evaluation.
- * It is very difficult to predict a replacement cycle for trees as there are several factors that will contribute to a tree dying. Factors such as disease, infestation of insects, heavy snow storms, etc. can all attribute to eventual tree replacement.
- * Since it is difficult to predict when the replacement will be necessary, Reserve funding is typically not a factor. Therefore, unless requested by the association, Reserve funding will not be included as part of the study for this component.

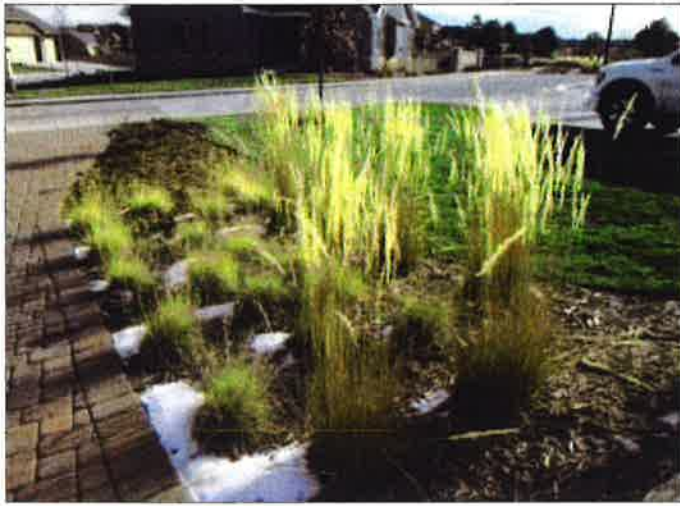
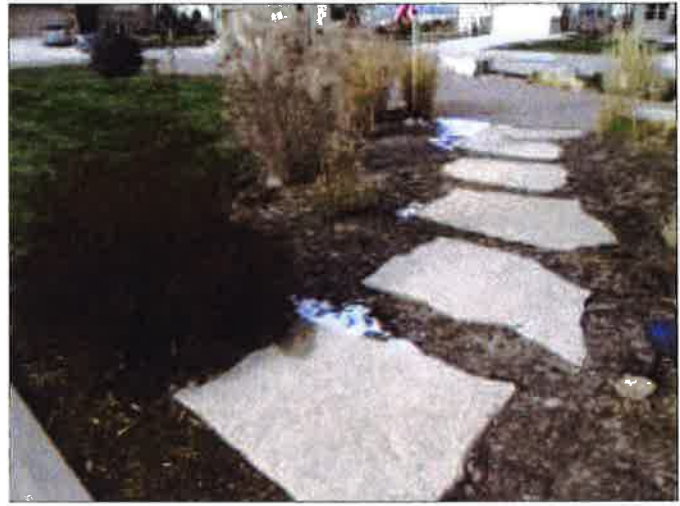
Comp #: 1801 Groundcover - Replenish

- * Typically, associations will establish a line item in the operating budget to handle annual replacement of shrubs, plants, grass areas, etc.
- * Therefore, separate Reserve funding is not necessary as long as funding has been established in a separate budget.
- * If the association prefers to include a funding allowance for groundcover replenishment, then we would need to know how much and how often the current board of directors would prefer to set aside since this would be considered a discretionary expense.

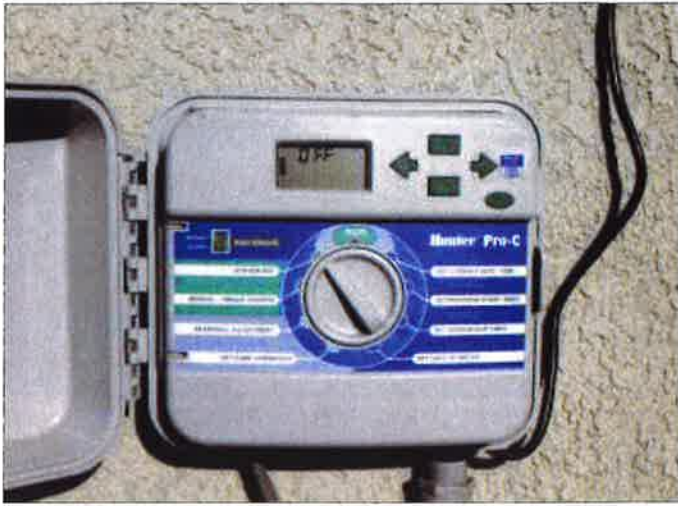
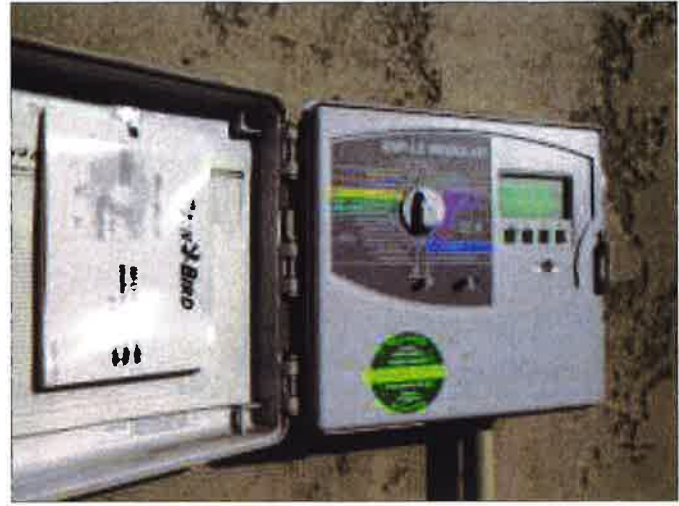
Comp #: 1703 Irrigation Controllers - Replace

- * Ages of controllers varied, with the majority being installed in 2012. No reported problems with the operation.
- * Expect to replace irrigation controllers every 10 - 12 years if properly maintained and under normal conditions.
- * Funding is for replacement with evapotranspiration based controllers as these are more efficient and can be controlled remotely by landscaping experts, saving the association irrigation water costs.

10311 - Hunter Xcore, 5 stations, 3/2012
 2917 - Hunter ProC, 12 stations, 3/2012
 2953 - Rainbird ESPLX modular, 07MY01 ("only")
 2989 - Rainbird, ESPLX modular, 10SE01, 12 active
 3013 - Hunter ProC, 12 stations, 3/2012
 3037 - Hunter Xcore, 3 stations, 3/2013
 3061 - Hunter ProC, 9 active, July 2011
 3073 - Rainbird, ESPLX modular, 24N006, 18 active

\$1800/controller; Estimate to replace

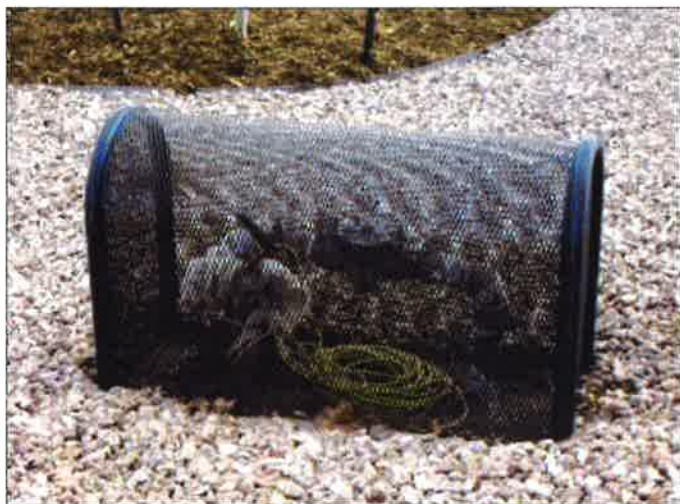
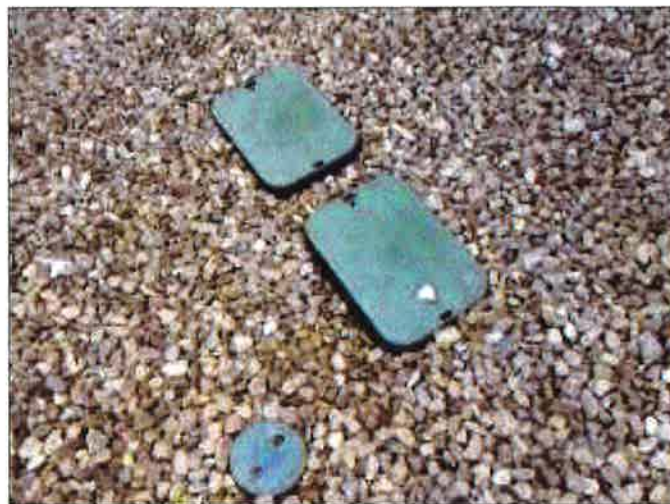
Comp #: 1701 Irrigation System - Major Repairs

- * No reported or observed problems with the system, as would be expected with newer systems.
- * This line item is for repairs and replacement that lies outside the scope of routine maintenance: bulk sprinkler head replacement, bulk valve replacement, rerouting lateral lines, rewiring, etc.
- * In order to ensure the funds are available for major repairs, we recommend reserving funds for these projects every 6 - 8 years.
- * The funding on this line item is for major repairs and is not to be interpreted as complete irrigation system replacement.

backflow is located at the end of drive by unit 2905

Estimate for major repairs and renovating system

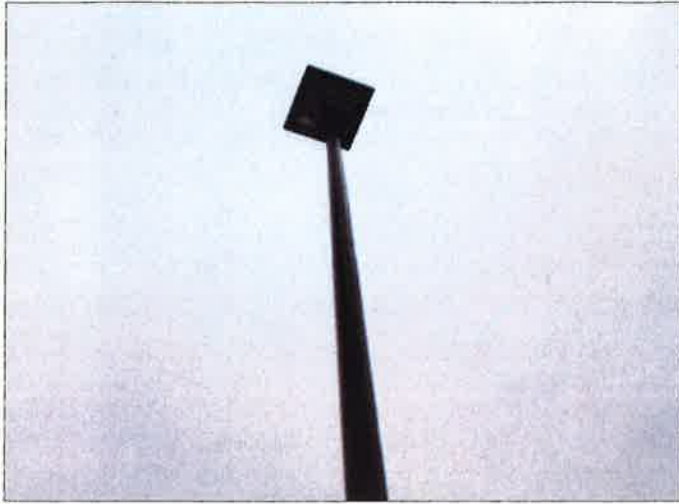
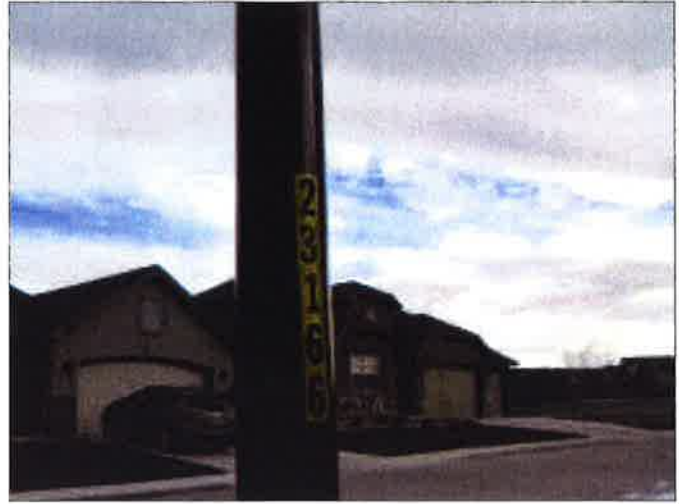
Comp #: 1609 Street Lights - Replace

- * These are the responsibility of the local public utility company, not the association.
- * Therefore, Reserve funding is not required for this component.

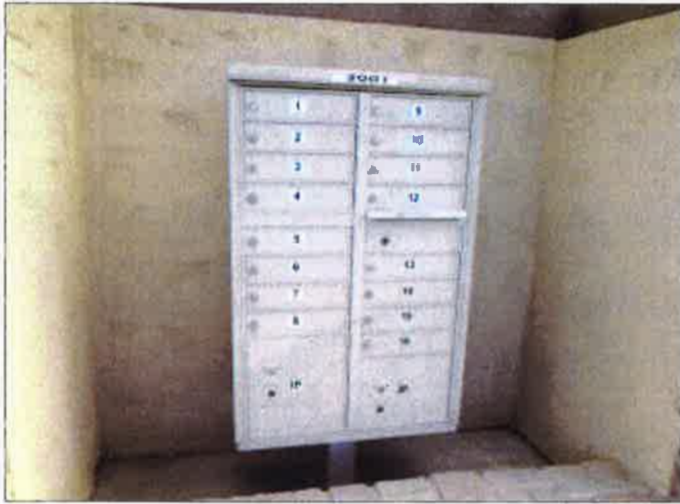
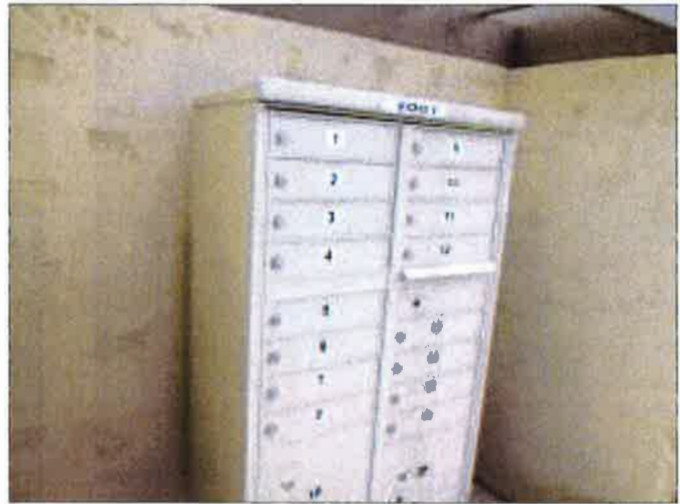
Comp #: 803 Mailboxes - Replace

* This line item is for the original mailboxes that were installed when construction of the community began in 2007/2008. Mailboxes are functional and in good condition (considering age) with no unusual conditions observed.

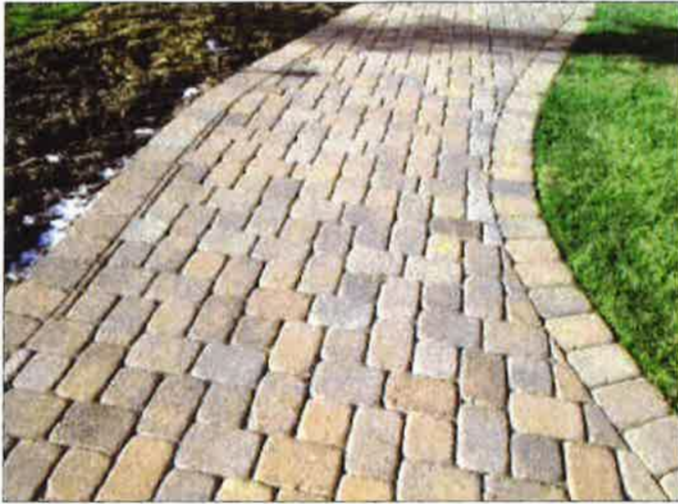
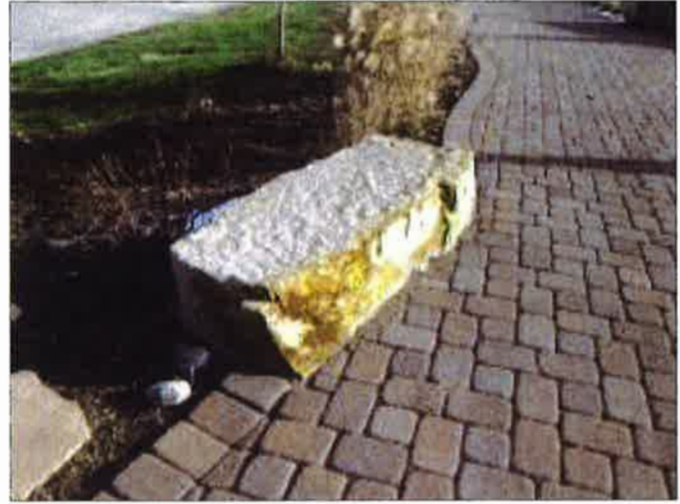
Comp #: 602 Concrete Pavers - Repair

- * All surfaces were even and in good condition with no deterioration or trip hazards noted at time of evaluation.
- * This type of walkway is subject to shifting and settling, which can result in tripping hazards. Being a public access area, it is very important to maintain a level surface at all times.
- * Therefore, we have established a line item for periodic inspections and repairs to maintain a safe surface at all times. The remaining life is based on observed conditions.

Allowance for major repairs every 12 years

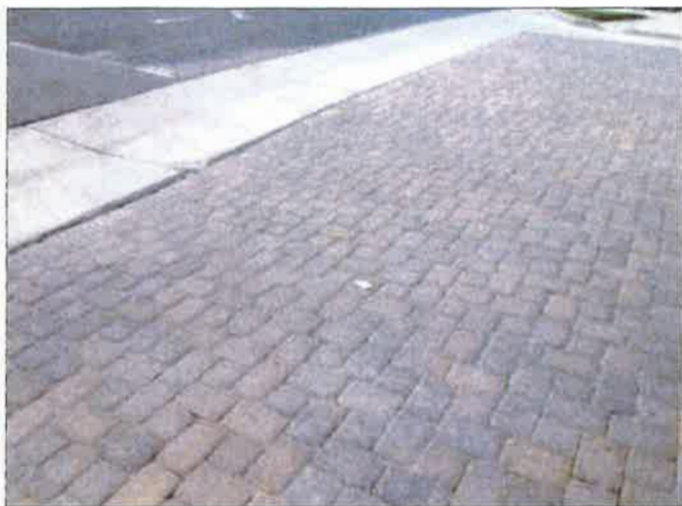
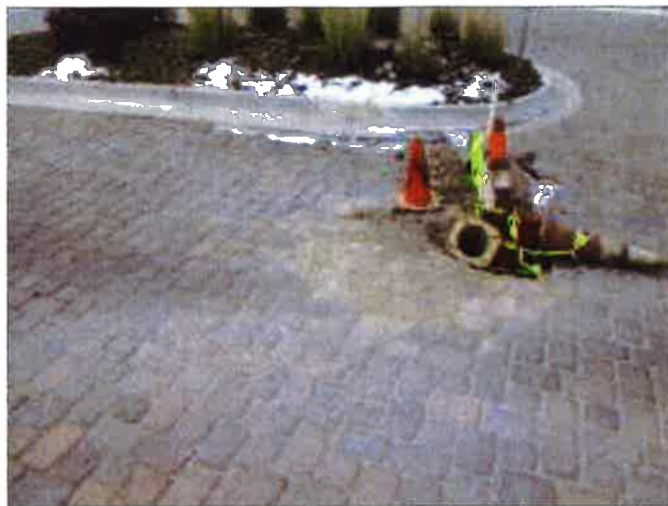
Comp #: 404 Concrete Pavers - Repair/Replace

- * At the time of the site evaluation, we noted an area that was in process of being repaired for an unknown reason.
- * Pavers themselves will have a long life expectancy, but over time, settling and deterioration will develop. Since pavers can be re-used, or new pavers can be purchased, we recommend establishing funding for major repairs, as opposed to complete replacement.
- * The remaining life is based on current repairs and evidence of some other settling that is not being repaired.

Allowance for major repairs every 6 years

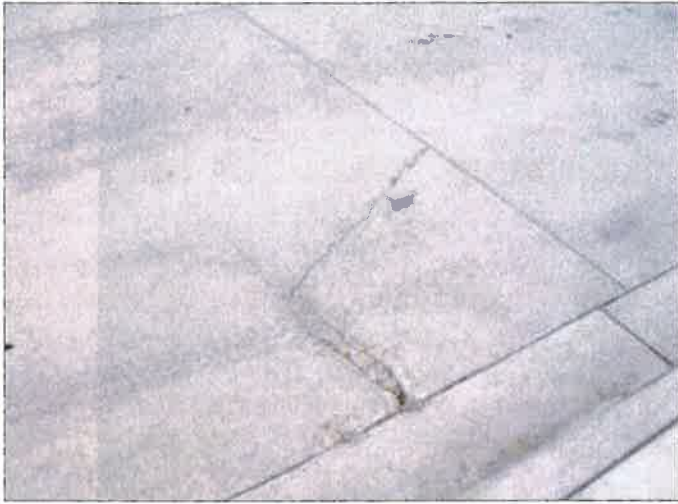
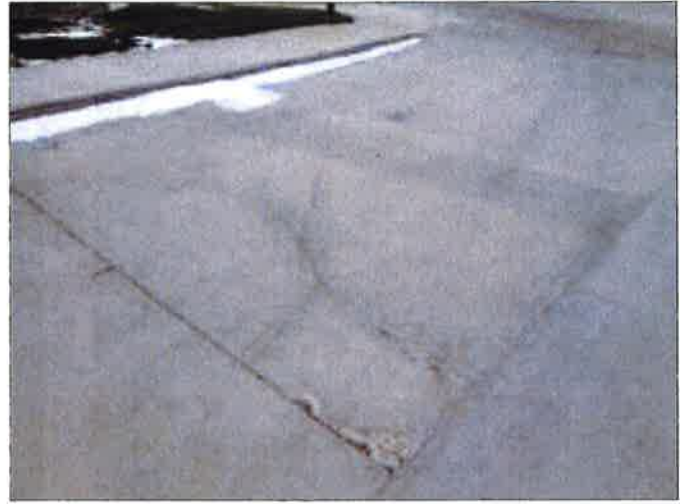
Comp #: 403 Concrete - Repair/Replace

- * Evidence of past repairs, and some cracking/spalling noted throughout drive surfaces. When repairs are required, we recommend cutting out sections from expansion joint to expansion joint for best future results.
- * It is unlikely that all concrete will fail and need to be replaced at the same time, therefore, we recommend Reserving to replace approximately 10% of the area (2,430 GSF) every 3 years.
- * Coordinate this project with other concrete projects for best cost estimates based on quantity of work.
- * Requested by client to extend remaining life to 2017, considering repairs were "just completed in Fall of 2013 and summer of 2014".

Estimate to replace 10% of area every 3 years
